2025

Asset Management Plan Water Services
The Corporation of The City of Peterborough

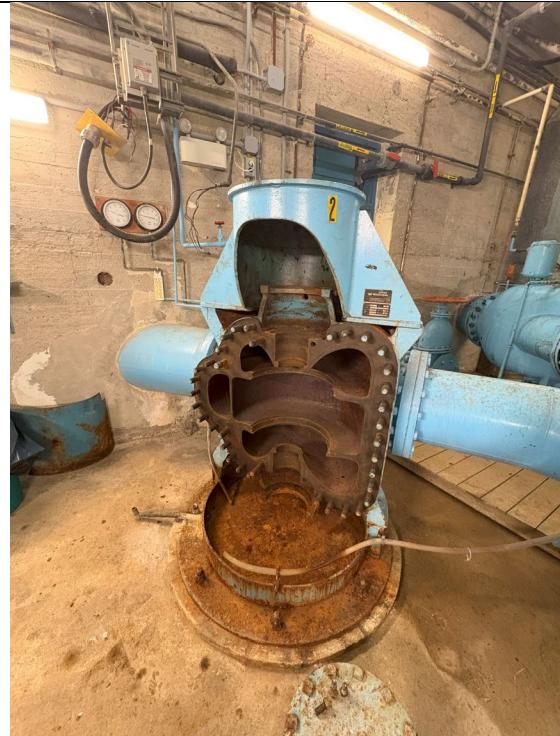
Figure 6: Electric Pump #2 Being Repaired

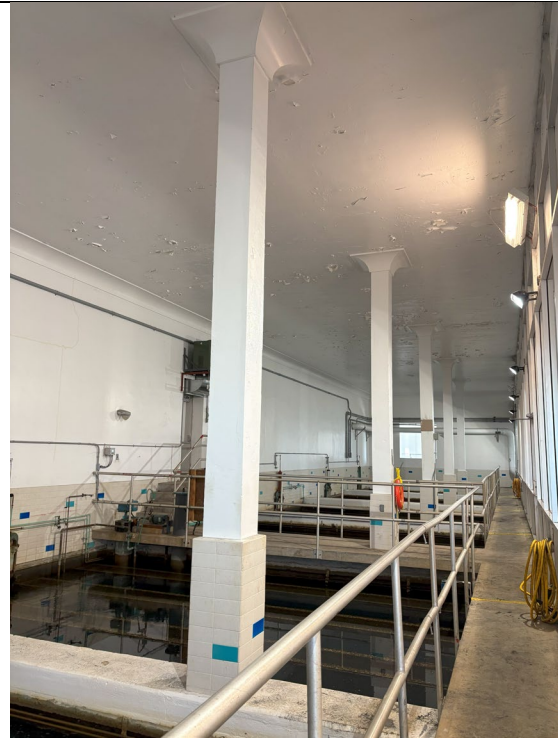
Figure 29: Filter Gallery Ceiling in Need of Repairs

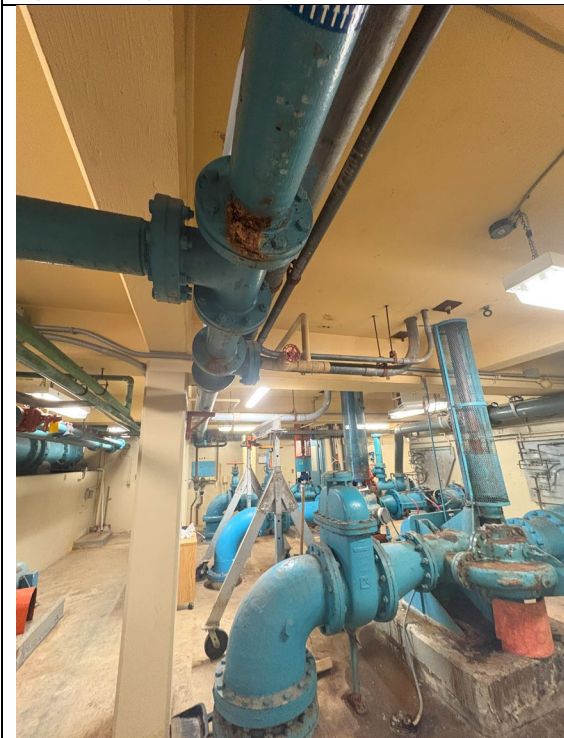
Figure 79: Plant Service Water Piping Corrosion

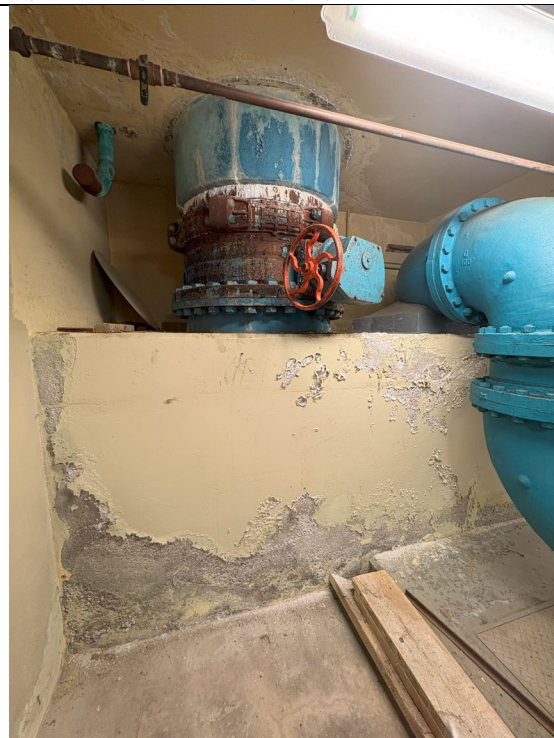
Figure 80: High Lift Pump Piping Corrosion

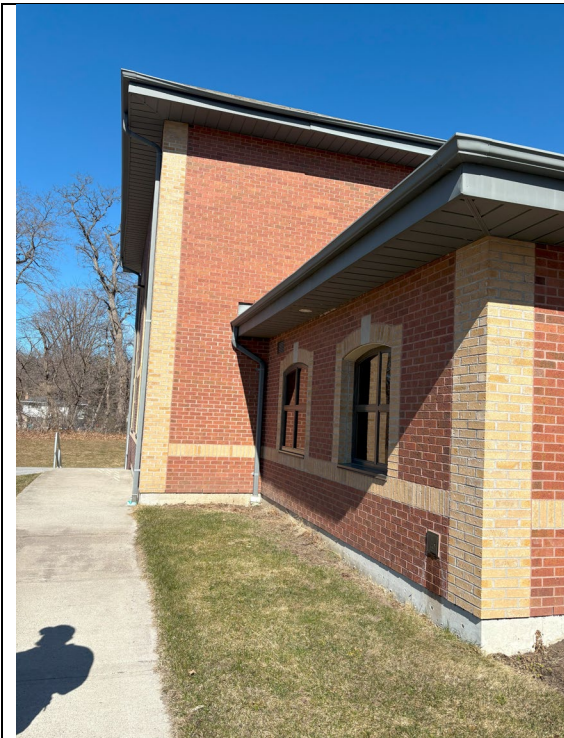
Figure 125: Exterior Eavestrough Bent

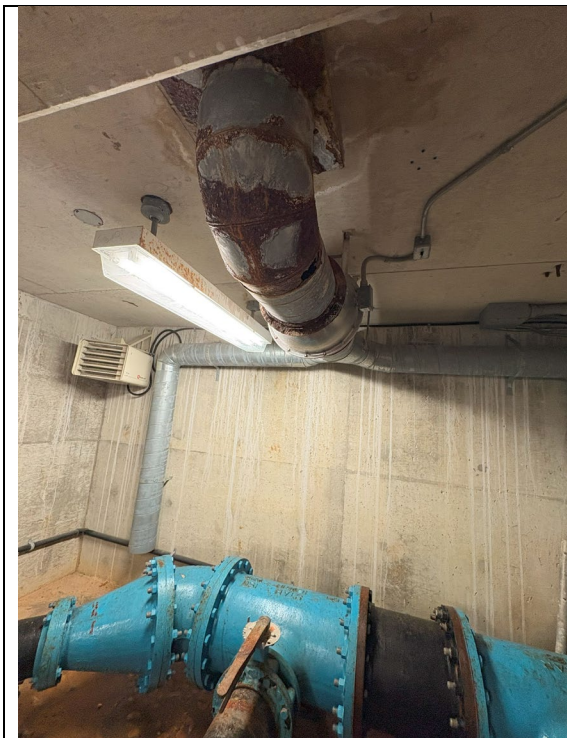
Figure 191: Ventilation Corrosion, Needs Repairs

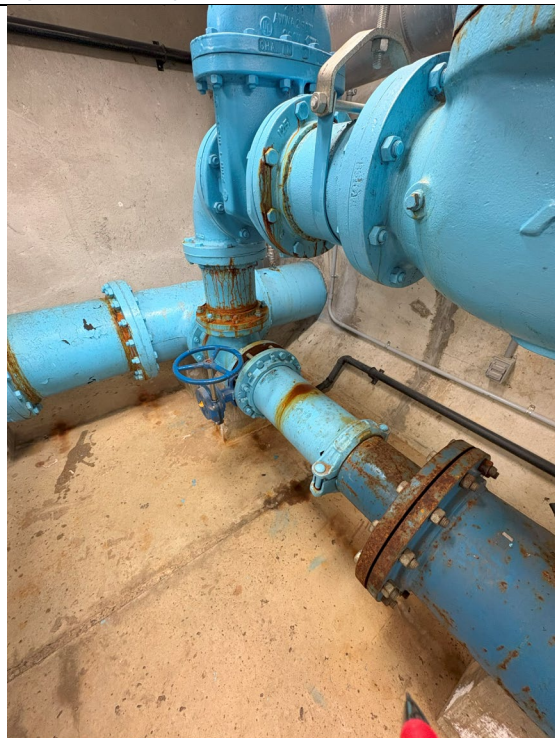
Figure 260: Corrosion on Tee

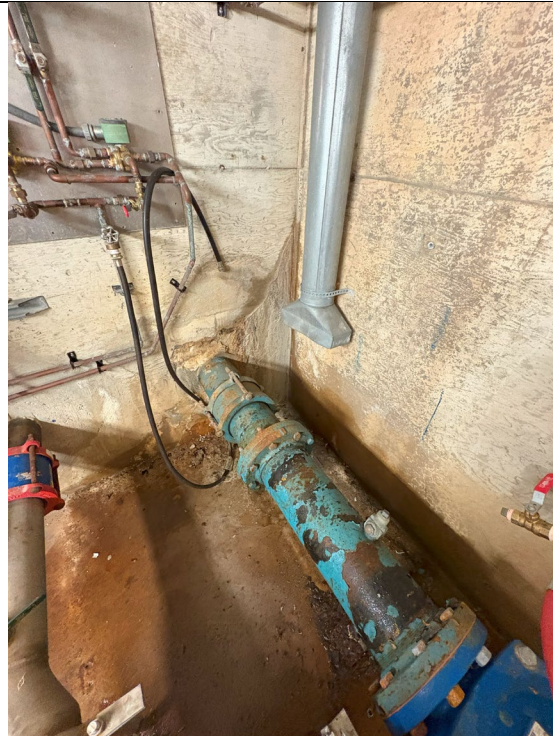
Figure 303: Corrosion of Pipe

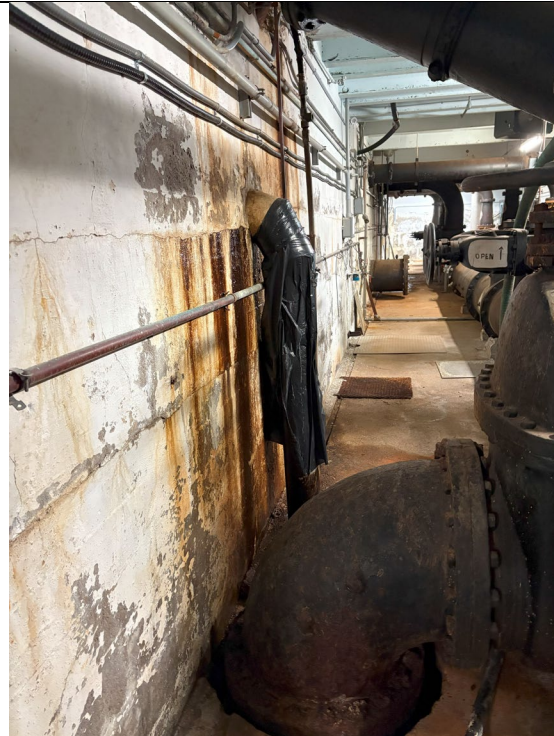
Figure 343: North Wall Water Damage

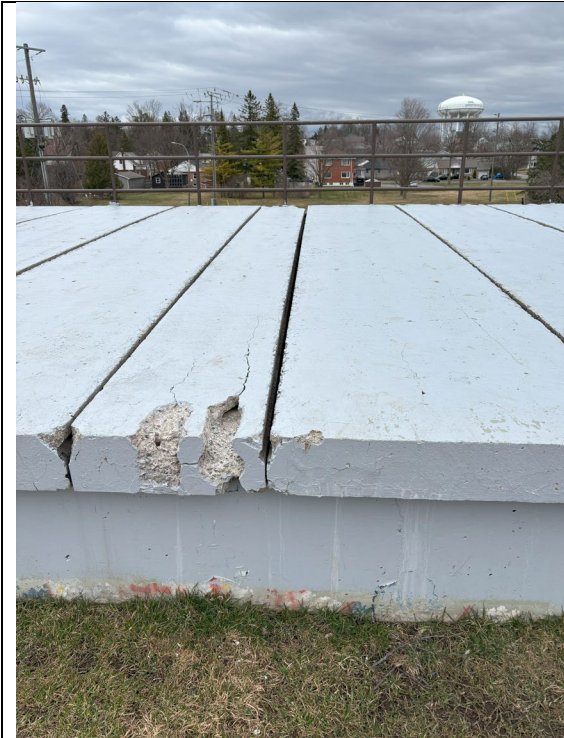
Figure 539: Deteriorated Concrete Roof

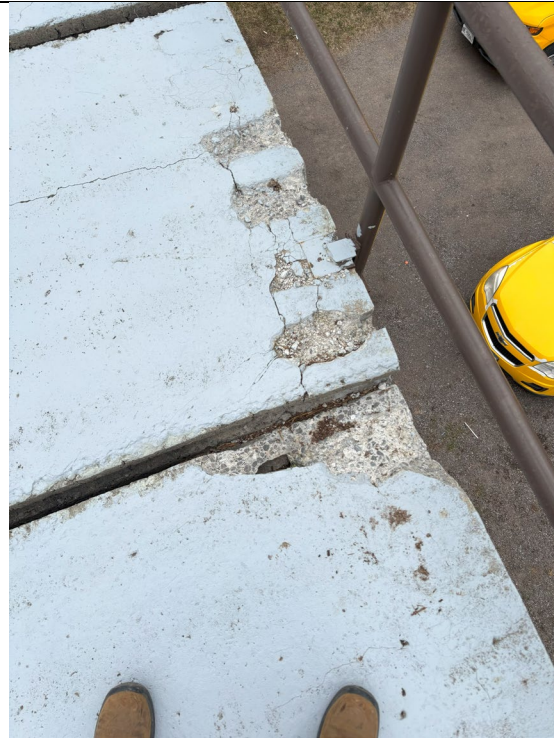
Figure 540: Deteriorated Concrete Roof

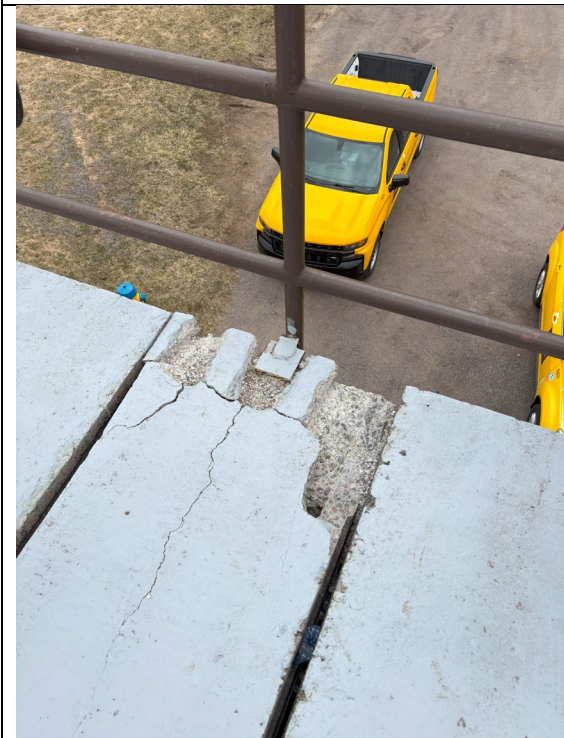
Figure 541: Deteriorated Concrete Roof

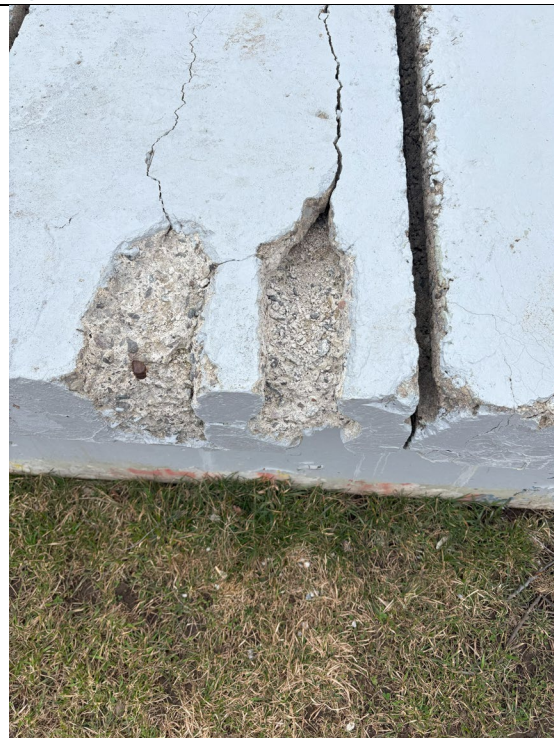
Figure 542: Deteriorated Concrete Roof

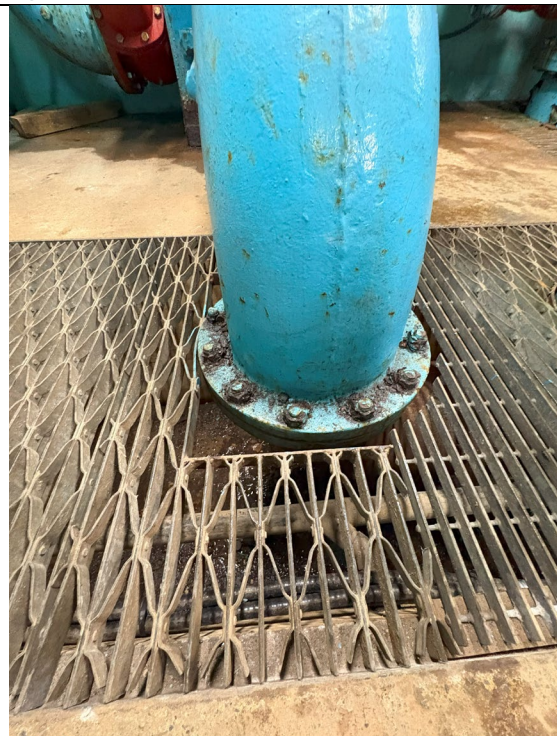
Figure 582: Corrosion on Flange

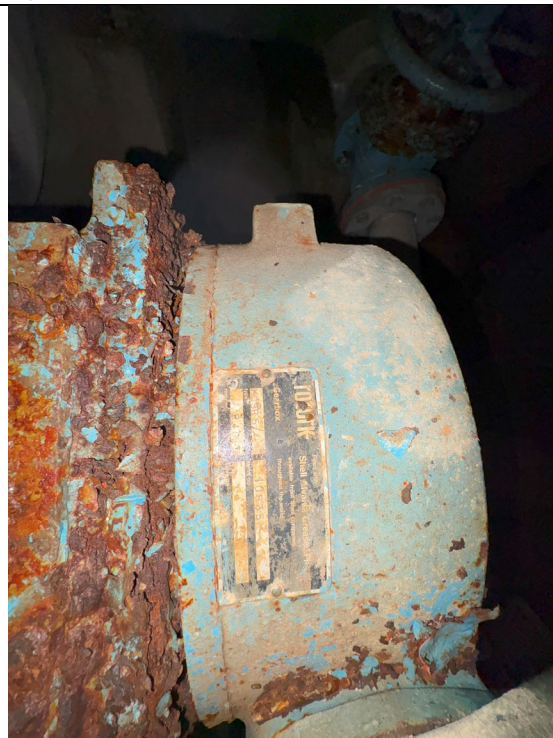
Figure 606: Corrosion Occurring on Process Piping

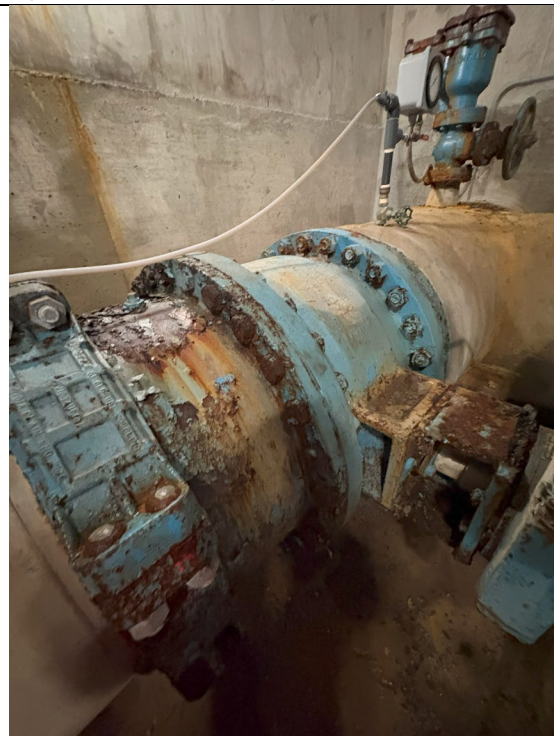
Figure 610: Corrosion Occurring on Process Piping

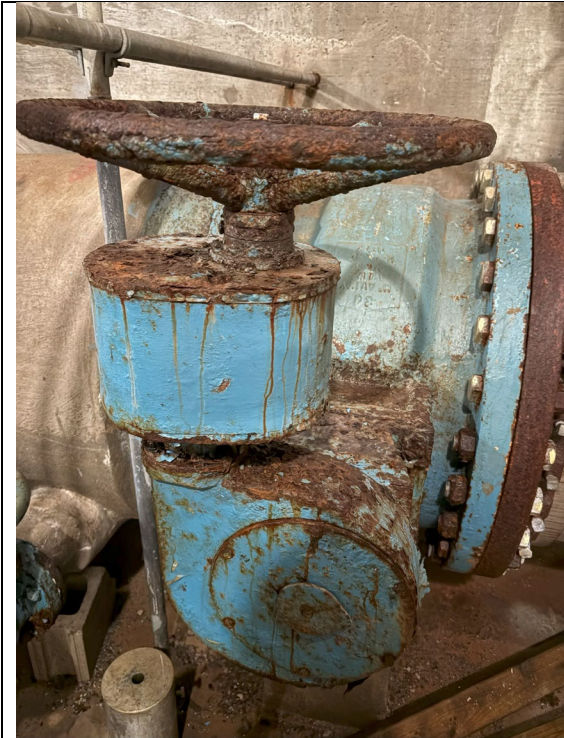
Figure 611: Corrosion Occurring on Process Piping

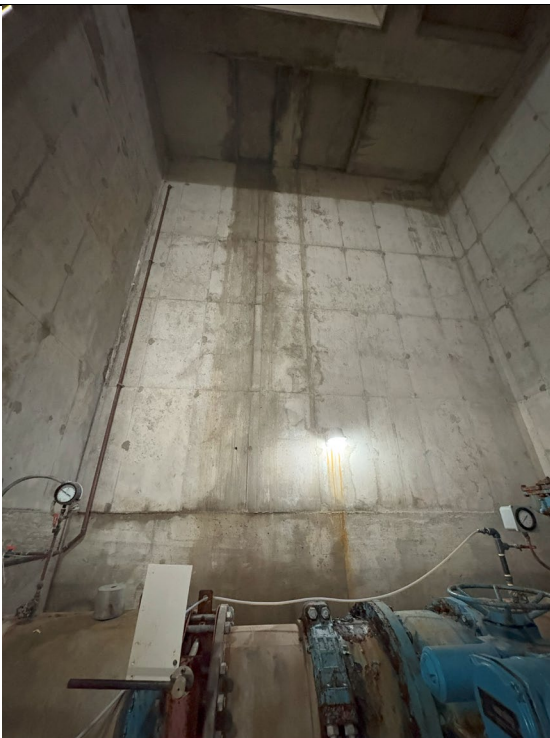
Figure 621: Pipe Room Ceiling, Surface Water Leaking
