City of Peterborough Stormwater Asset Operations Report ECA# 145-S701

April 30th, 2024

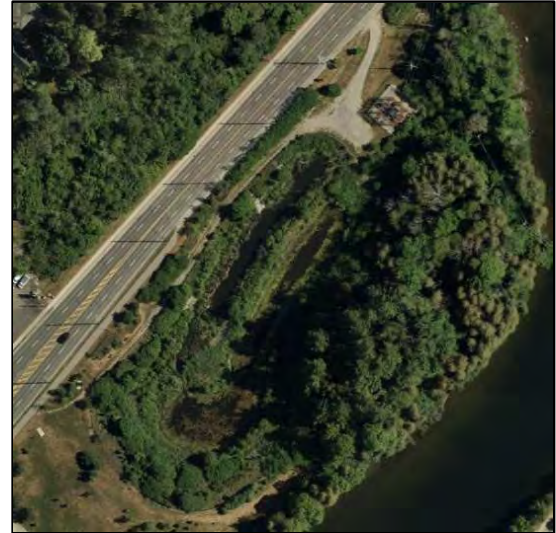
Table A-1.1: Water Street Pond 2021 Sediment Survey Data

The weather was cloudy. The water level is normal. The water was clear. Trees were downed around the pond due to a beaver activity. Some algae growth in the pond. Inlets have structural damage but are still functional. Slight blockage of the outfall restricting outlet. Fence repair is required due to a fallen tree.

The Water Street Pond is in fair condition. The 2021 sediment survey concluded the capacity of this facility is above the minimum MECP maintenance trigger volume, and the facility is only 22% below its original design capacity. No major sediment removal is required currently. However, the forebay should be considered for a clean-out when feasible.

There are many trees down that could be removed and there is a blockage in the outfall that should be cleared out. Fence damage that needs to be repaired. Most importantly, the inlet structure is severely damaged and should be repaired as soon as possible.

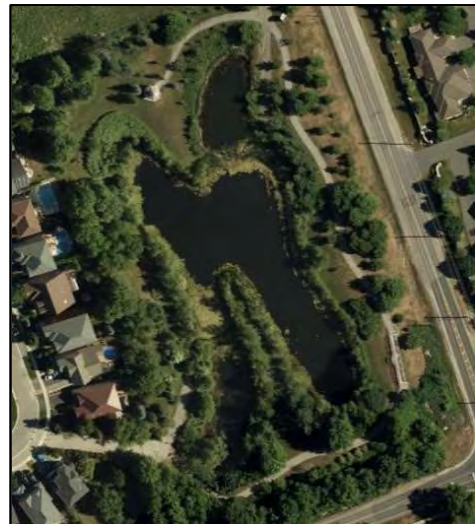
Table A-1.2: Heritage Park Pond 2021 Sediment Survey Data

The Heritage Park Pond is in fair condition overall, both facility forebays were cleaned out in 2017 by the developer. The current capacity per the 2021 sediment survey of this facility is well above maintenance and design capacity indicating this pond was built deeper than design. No major sediment removal is required currently.

Vegetation overgrowth should be cleared from the inlets to the facility as soon as possible. There is an improperly constructed overland flow weir that needs to be corrected that was identified prior to releasing securities to the developer. The developer has made payment to the City to an agreed upon amount to correct this issue.

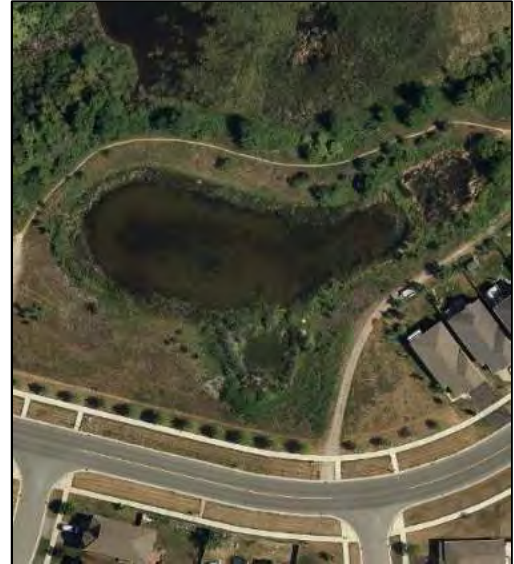
Table A-1.3: Cunningham Pond 2021 Sediment Survey Data

Weather Sunny rain within the last 2 days.
Water is clear. Vegetation overgrowth in forebays and outlet. The southern inlet and forebay is in good condition, the eastern inlet is fully engulfed in aquatic vegetation. Dead vegetation clogging outlet restricting flows. General litter around the pond.

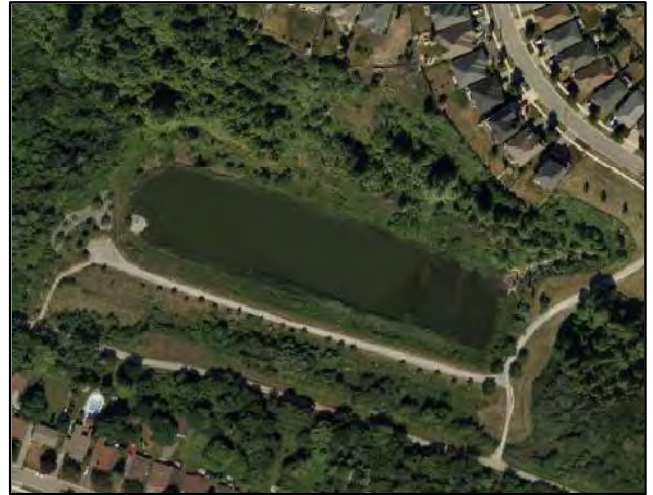
Table A-1.4: Towerhill North 2021 Sediment Survey Data

Weather cloudy, slight rain. Water clear. Damage to the inlet. Headwall structure leading to the outfall clogged with vegetation growth restricting flow. Heavy invasive plant presence. General trash and debris around facility. Trees that still have collars. Outlet outfall is submerged and creating bubbling pool of water, requires rip-rap top up.

The Towerhill North Pond is in fair condition overall. The 2021 survey capacity of this facility is above the minimum MECP maintenance trigger volume, and the facility is also above its original design capacity. No major sediment removal is required currently. The 2021 survey indicated that the forebay is slightly deeper than its design depth.

The outlet structure of this facility is prone to clogging. A redesign of the outlet structure is recommended when major maintenance operations on this facility are conducted. The grate on the inlet is missing bolts; this has left an opening into the storm drain. Phragmites make up most of the aquatic plants at the facility. Removal of these invasives is recommended.

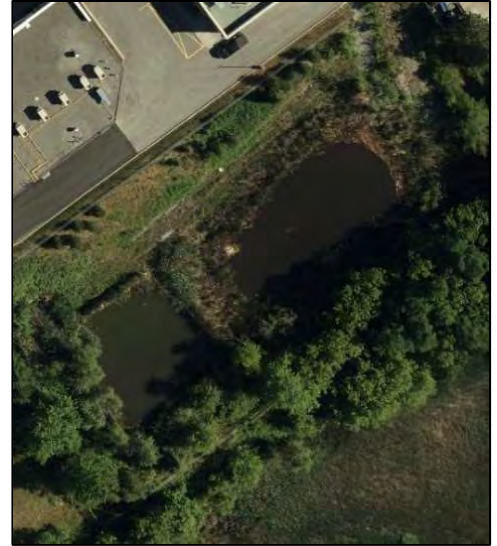
Table A-1.5: Chemong Park Plaza 2021 Sediment Survey Data

Weather Cloudy, rain in last 48 hours. Water is murky, has foul odour and sheen is visible. Aquatic vegetation is overgrown. Downed fence on north side of facility. Lots of garbage and debris throughout facility. Damaged inlet headwall. Outlet grate covered in debris. Sediment accumulation at inlet and outlet. Heavy invasive phragmite presence within facility.

Chemong Park Plaza Pond is in fair condition overall. The 2021 sediment survey capacity is above the minimum MECP maintenance trigger volume, and the facility is also above its original design capacity. The survey also indicated that the forebay of this facility was built much deeper than design.

The water in the pond has a foul odor, especially at the Inlet. Water quality tests have been done to better understand the issue however there is no definitive source assumption is that it may be due to restaurant grease leaking, further investigation is required. The excessive amounts of trash around the pond should be removed. A large section of the fence is down and should be repaired. Damaged structures should be repaired. Removal of the invasive phragmites and accumulated sediment at inlets and outlets is also recommended.

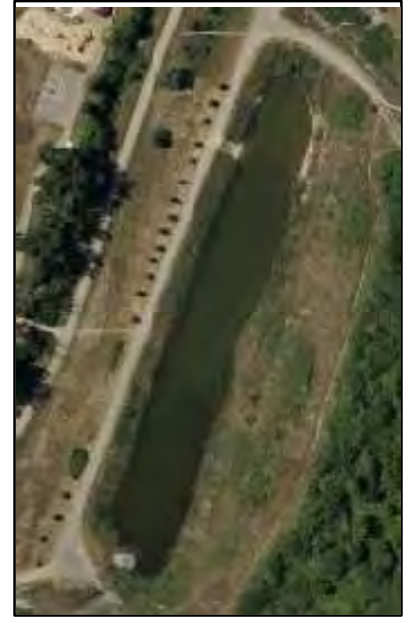
Table A-1.6: Towerhill South Pond 2021 Sediment Survey Data

Weather cloudy with slight rain. Water appeared to be murky, and sheen was visible in the pond. Garbage around the pond. Missing warning sign indicating storm water management pond. Debris in the inlet, grate is open. Outfall from the outlet is covered in aquatic vegetation restricting flow. Sticks in the outlet structure. Heavy Invasive phragmite presence.

However, the phragmites which were recently removed have already returned to the pond. An estimated 60% of all aquatic plant species is phragmites. A more robust treatment should be considered to preserve the pond's biodiversity. The outlet is overgrown with the invasives, which could cause blockages. The inlet structure's trash rack is missing some bolts and requires repair. The hickenbottom has some debris in it which should be removed. A safety sign is missing and should be installed at the site.

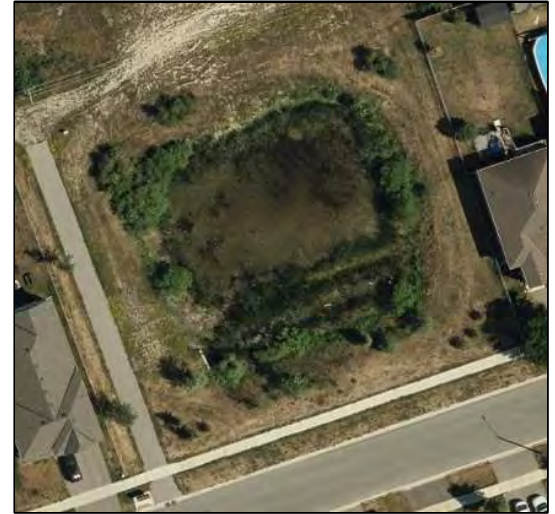
Table A-1.7: Foxmeadow Pond 2021 Sediment Survey Data

Foxmeadow is in good condition overall, the pond was cleaned out in Fall 2018. The 2021 survey of this pond indicates it is above both MECP and design volumes. The forebay remains just below design depth.

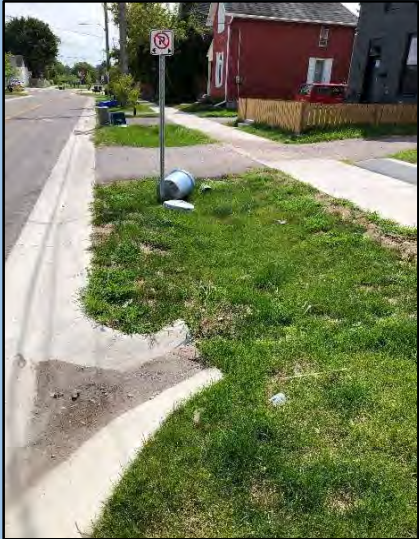
183 Bethune St. (August 15, 2023)

Location	183 Bethune St running underneath the driveway on the west-hand side of the road, the curb bends into the swale from Bethune St.	
Description	Grassed swale between the sidewalk and road with PVC pipe running underneath the driveway. Break in curb leading into the swale.	
Condition	Good condition structurally, with some sediment in the inlet and some debris in the bottom of the swale	
Maintenance required	Clean out accumulated sediment in spring 2024

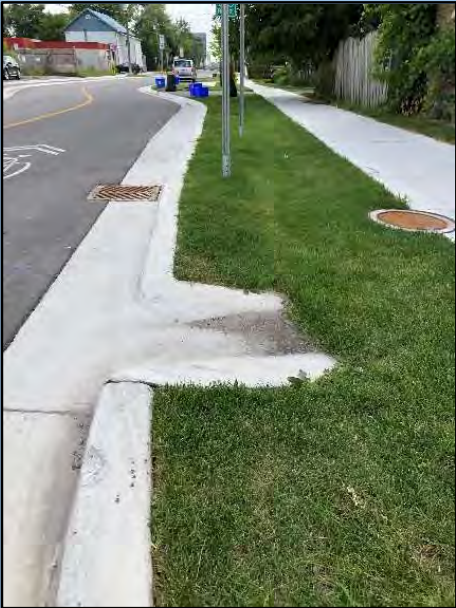
West Side of Bethune Corner of McDonnel (August 15, 2023)

Location	West-hand side of Bethune St at the corner of McDonnel between the sidewalk and Bethune St on the south-hand side of McDonnel St	
Description	Grassed infiltration swale with curb cut inlet.	
Condition	The LID is in good condition but there is a small buildup of sediment on the curb leading to the swale.	
Maintenance Required	N/A

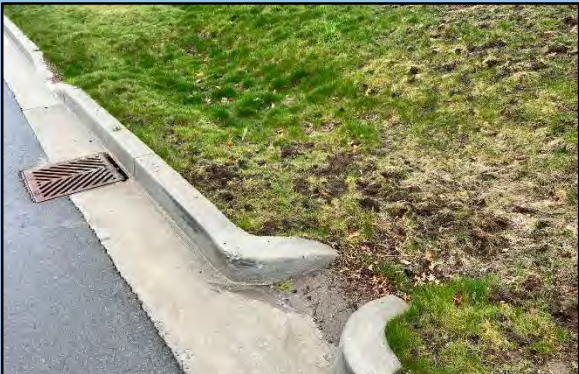
West side of Moorecraig Rd. (September 2023)	
Location	West side of Moorecraig Rd. in the boulevard.
Description	4 grassed infiltration swales complete with curb cut inlets and monitoring wells.
Condition	Generally good condition, sediment accumulation at curb cuts. Thatch buildup in swales.
Maintenance Required	Remove accumulated sediment and debris from the inlet, and remove thatch from the swale. Replace monitoring well missing cap.

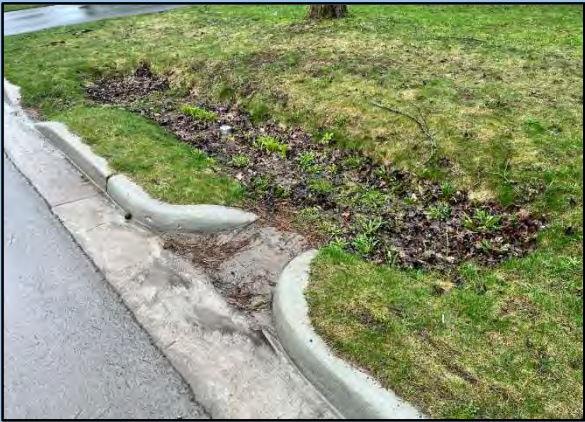
South Side of Roper Drive. (September 2023)

Location	South side of Roper drive between Moorecraig and Wallis	
Description	6 Grassed infiltration swale with two trees. Curb cut inlet	
Condition	Generally good condition, sediment accumulation at inlets, leaf and debris build up in swale. Cap missing from one monitoring well. One outlet curb cut blocked by a mailbox	
Maintenance Required	Remove accumulated sediment and debris from the inlet, and remove leaves from swales. Replace monitoring well missing cap. Move mailbox from outlet.
