2025

Asset Management Plan Water Services
The Corporation of The City of Peterborough

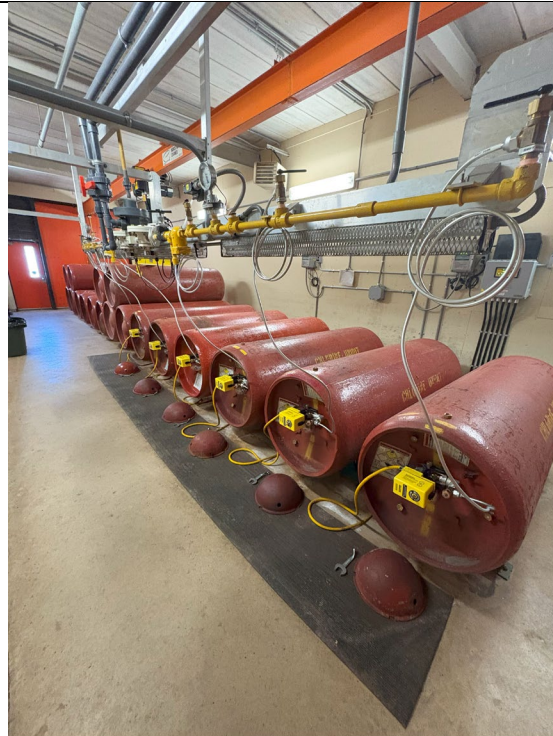
Figure 82: Chlorine Gas Cylinders

The Chlorine Storage Building is adjacent to the water treatment plant. It is a brick, one story building on the East side of the main building. The Chlorine Storage Building can house up to 18 - 1 ton chlorine gas cylinders. The chlorine gas scrubber is located immediately to the south. No concerns were identified with the chlorine storage building or the chlorine injector room and are both in good condition.

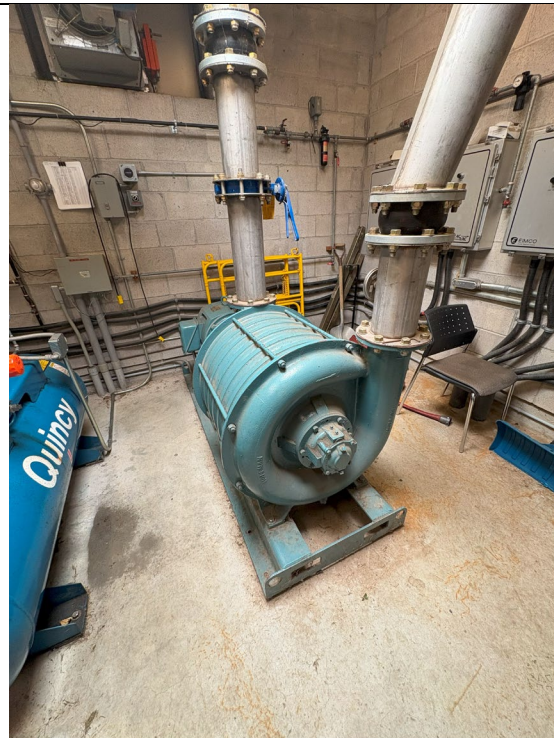
Figure 90: Air Scour Filters

The Blower Building is adjacent to the water treatment plant Filter Gallery. It is a brick, one story building. The Blower Building houses air compressors and air scour filters. No concerns were identified with the blower building and it is in good condition.

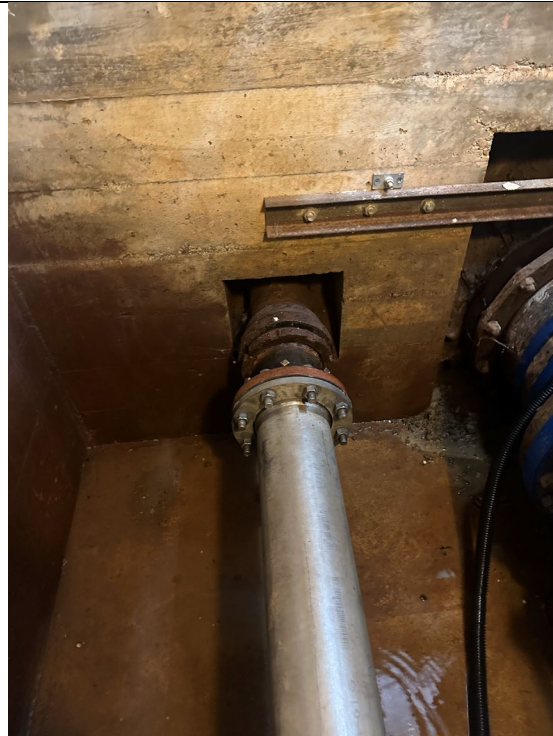
Figure 442: Drainpipe

The tower is fed with a 500mm stainless steel pipe and is in good condition. A new 500mm gate valve was installed in 2021. There is a defect in the drainpipe, resulting in a consistent leak. The drainpipe requires repairs.
