City of Peterborough Stormwater Asset Operations Report ECA# 145-S701

April 30th, 2024

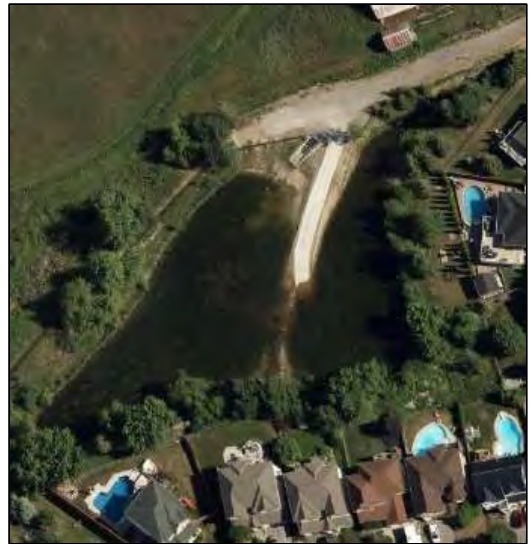
Table A-1.9: Fairview Pond 2021 Sediment Survey Data

Weather sunny with some rainfall within 48 hours.
Water level normal, clear minor algae growth.
Structures appear to be in good standing. Minor debris inside the outlet structure. Some erosion along the edges of the cable-crete access.

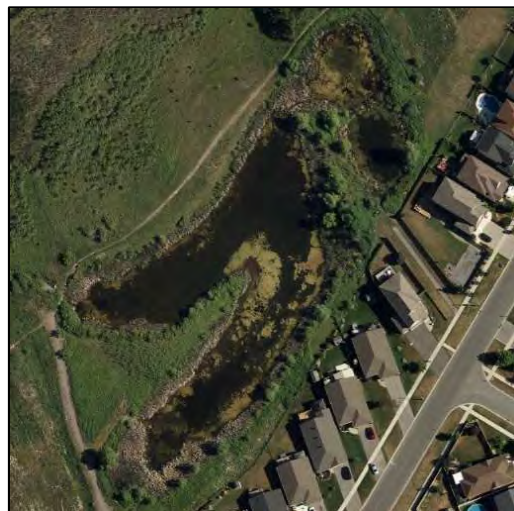
Table A-1.10: Loggerhead 2 2021 Sediment Survey Data

Weather Sunny, rain within last 48 hours. Water level normal, generally clear with some sheen, some algae development. Aquatic vegetation overgrowth blocking west inlet. Trash and debris throughout. Overland flow route missing rip-rap. Phragmite stand at southeast side of facility. Outfall channel requires reinstatement.

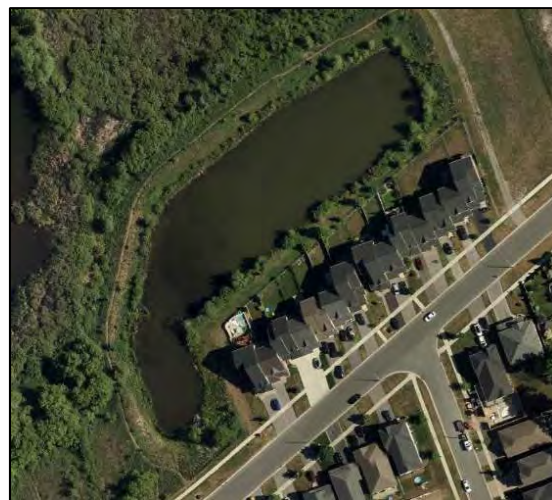
Table A-1.11: Loggerhead 1 2021 Sediment Survey Data

Weather Sunny, rain within last 48 hours. Normal water level, slightly cloudy. Inlet headwall structural issues, cracking around the pipe and the wings of the headwall appear to be breaking apart. Outlet in good standing.

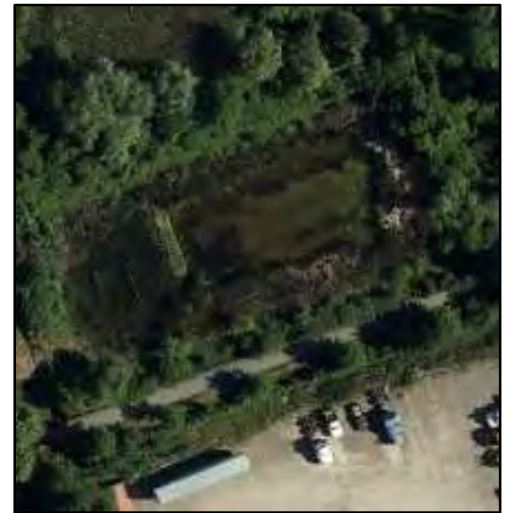
Table A-1.13: Wentworth 2021 Sediment Survey Data

Weather hot and sunny, rain within the last 48 hours. Water level normal, clear. Trash within the pond along with trash scattered around the berm of the pond. Forebay berm is partially submerged. The ditch inlet leading to the forebay is overgrown. Silt curtains to be removed or reinstated as required. Outlet structure appears clogged.

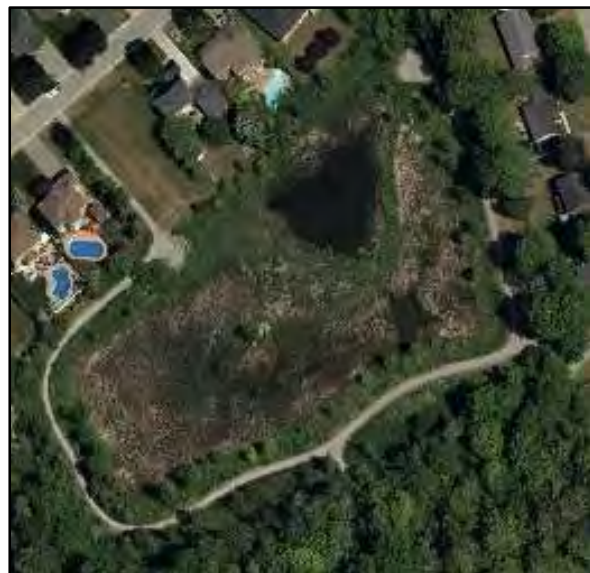
Table A-1.14: College Park 2021 Sediment Survey Data

Weather sunny with rain in last 48 hours. Water level normal and clear however heavy algae present. There is some minor erosion on the outer berm of the pond and some on the path. The wetland portion of the pond is maintaining a permanent pool as the outlet structure is clogged. The orifice on the inlet structure is also installed upside down.

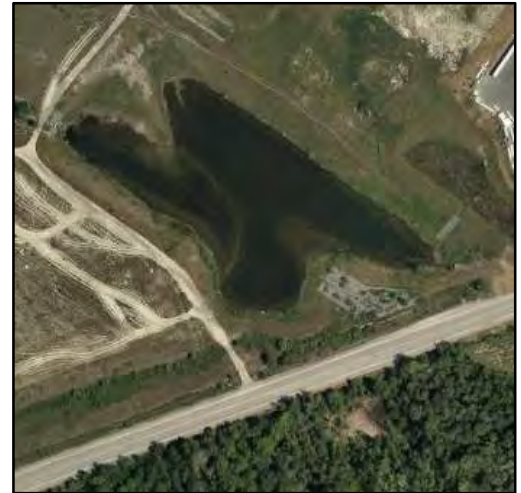
Table A-1.15: Major Bennett 2021 Sediment Survey Data Analysis

Weather Sunny. Water level slightly high, cloudy with some sheen present. Aquatic vegetation restricting flows at inlets and outlets. Garbage and debris present throughout pond block. Northwest inlet has detached from headwall. Access paths have rutting and ponding.

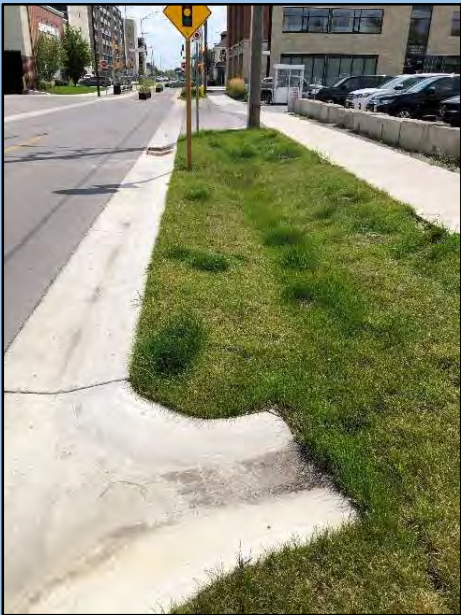
West side of the Bethune St Between Simcoe and Charlotte (August 15, 2023)	
Location	West side of Bethune St between Simcoe and Charlotte, between the sidewalk and Bethune St East of the parking lot
Description	Grassed infiltration swale with curb cut inlet.
Condition	This LID is in good condition with no issues.
Maintenance Required	N/A

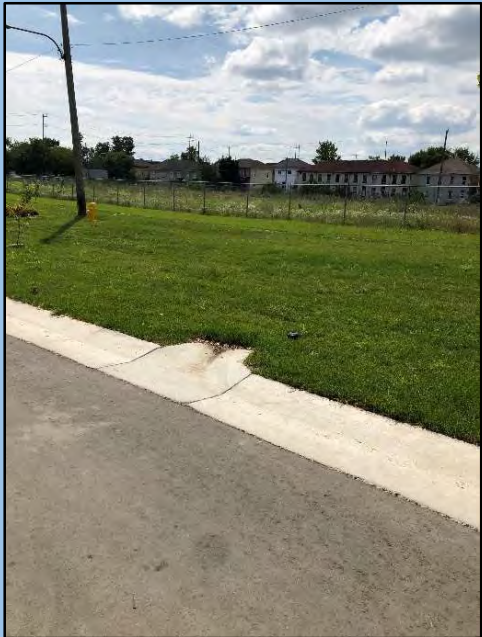
West side of the Bethune Corner of Wolfe (August 15, 2023)	
Location	West-hand side of Bethune St. just south of Wolfe St between the fence and the curb.
Description	Grassed infiltration swale with two trees. Curb cut inlet
Condition	LID looks to be in generally good condition, some sections of the grass are missing but not major vegetation loss
Maintenance Required	N/A

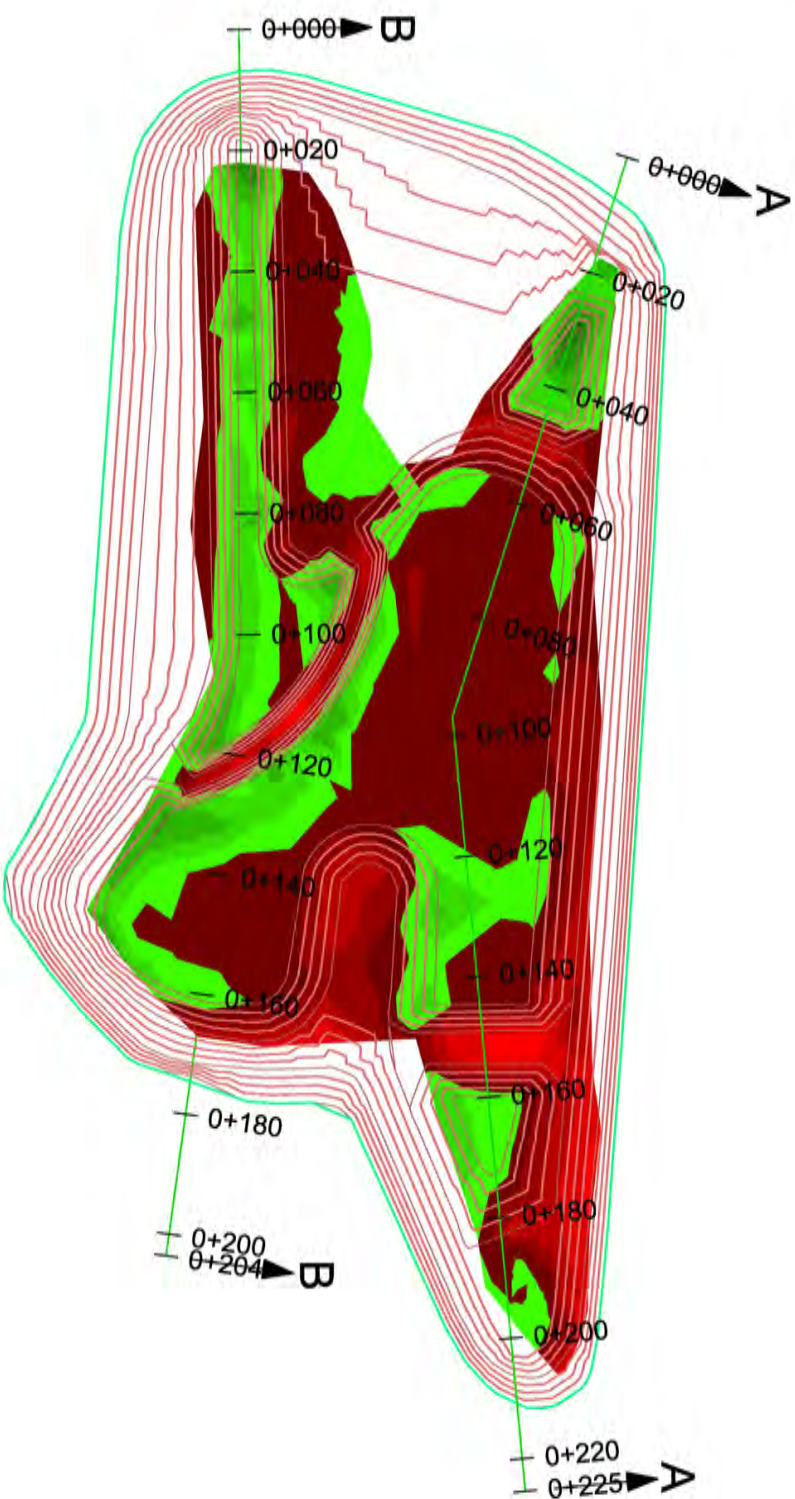
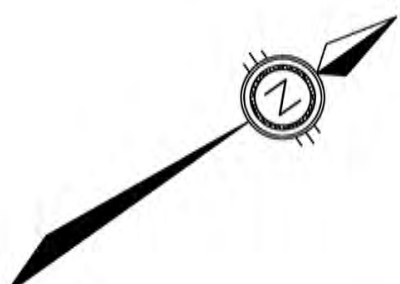
Loggerhead 2 Pond	
POND NUMBER: 18	CONTRACT NUMBER: N/A
DRAWN BY: C.M.	REVIEWED BY: X.X.X.
DATE: AUG. 12, 2021	SCALE: 1:1000

NOTE: LOGGERHEAD 2 POND WAS BUILT WITH THE EAST FOREBAY FURTHER EAST AND LARGER THAN DESIGN. ELEVATION TABLE IS COMPARING SURVEYED BOTTOM OF POND TO SURVEYED TOP OF SEDIMENT.
