2025

Asset Management Plan Water Services
The Corporation of The City of Peterborough

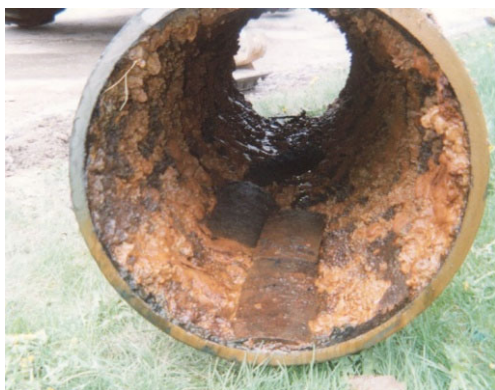
Figure 11: Cast Iron Pipe Tuberculation

As the cast iron and unlined ductile iron pipe in the water distribution system age, the interior of the pipe develops significant corrosion which results in pitting, tuberculation, and roughness inside the pipe. See Figure 11 below for an example of a highly tuberculated cast iron pipe.

When pressure and flow fluctuate, particulates due to corrosion can break away from the wall of the pipe and into the flow, causing discolouration and other aesthetic issues within the water. Internal corrosion also significantly contributes to pipe failure. Cement Mortar Lining (CML) of iron watermain provides a smooth inner lining which eliminates the roughness, reduces future corrosion potential, and helps minimize associated water quality issues.

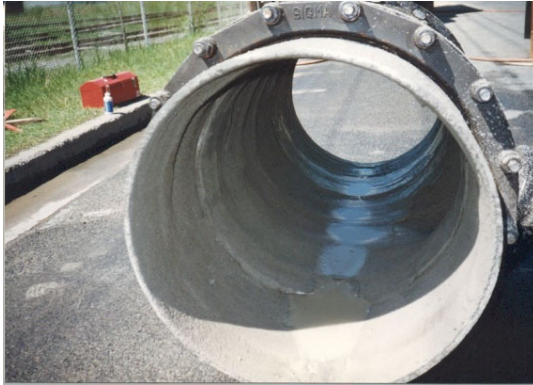
Figure 12: Cement Mortar Lined Watermain

Figure 12 below illustrates the final internal pipe condition following cement mortar lining.

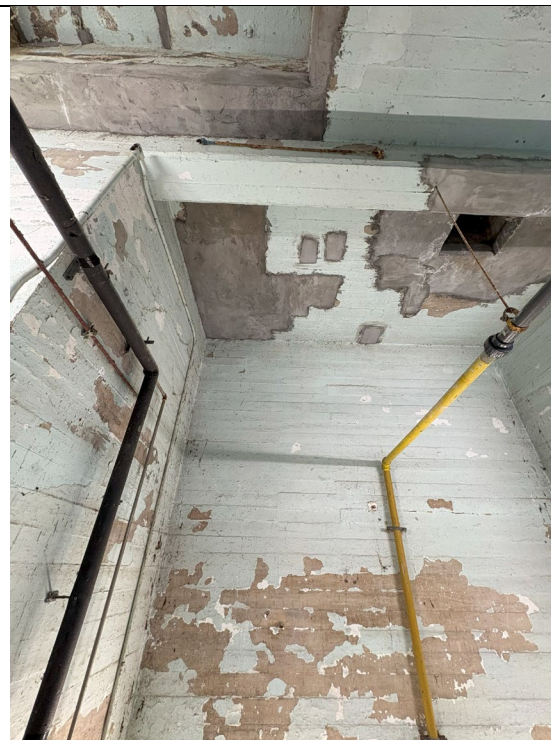
Figure 2: Wet Well Access Room Paint

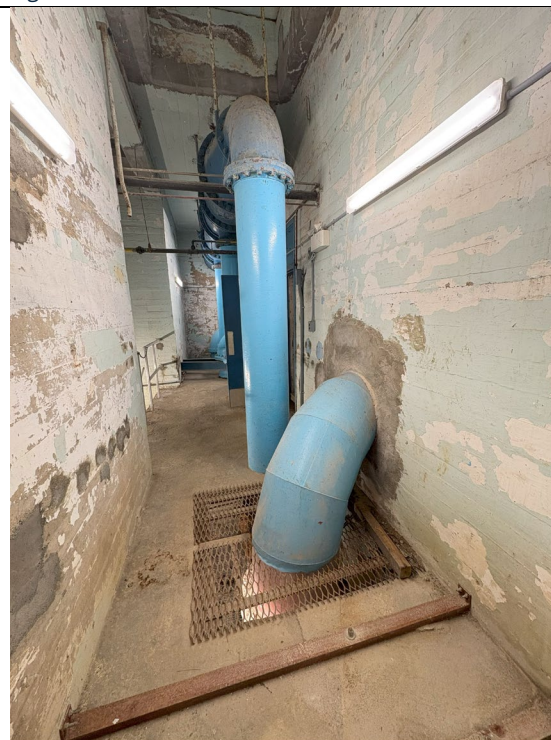
Figure 4: Piping Between Wet Well and Low Lift Pumps

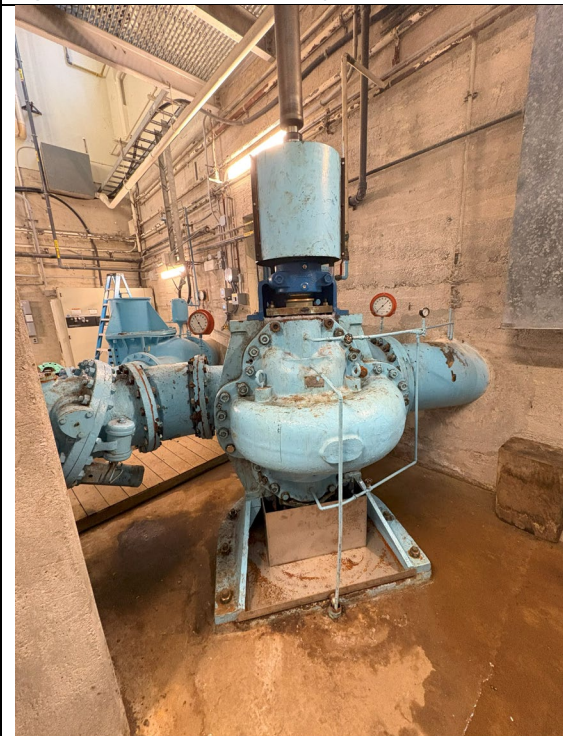
The pumps, check valves, and piping are all in fair condition.

Figure 7: Electric Low Lift Pump #3

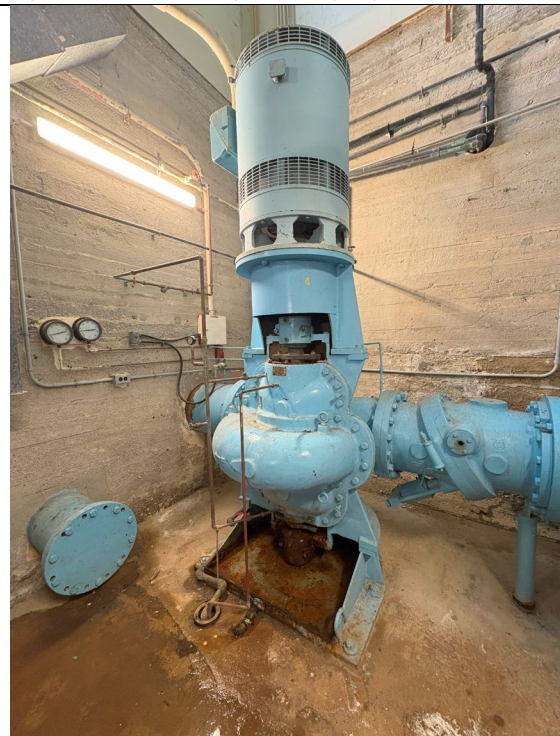
Figure 8: Electric Low Lift Pump #4

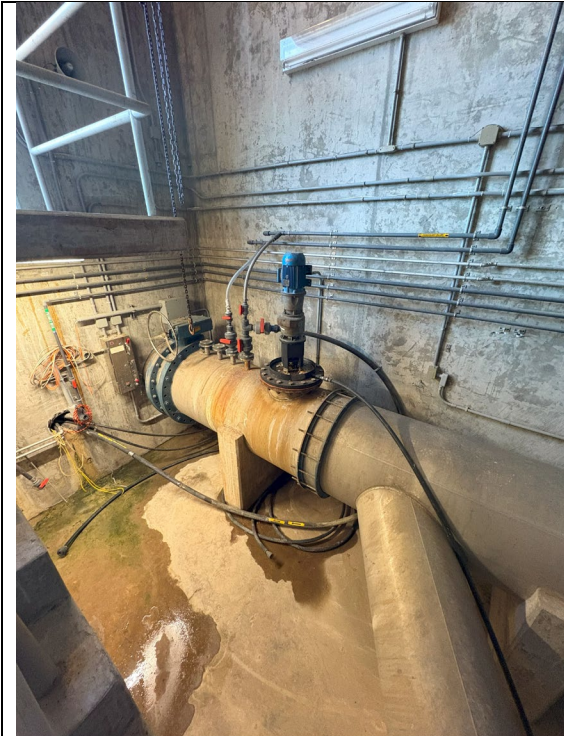
Figure 13: Raw Water Piping, Coagulation Injection Point

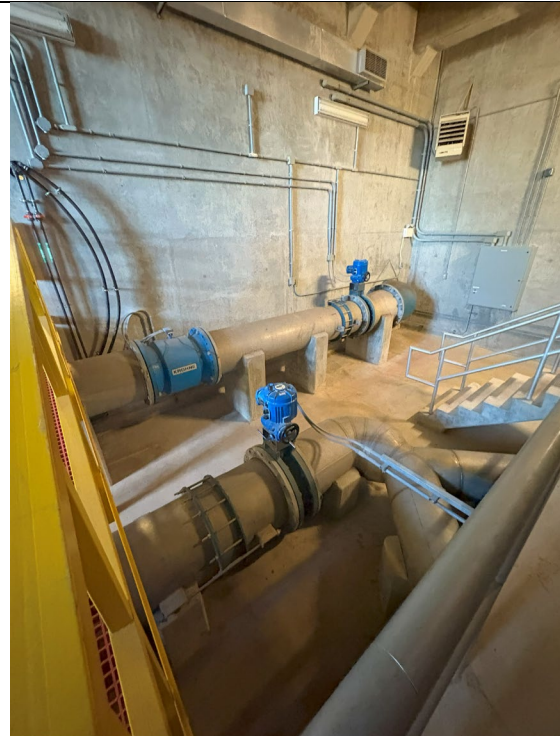
The chemical pumps are in good condition. Standby pumps are available for redundancy purposes. Duty and standby mixers are both in good condition.

Figure 14: Post Coagulation Injection Mixers

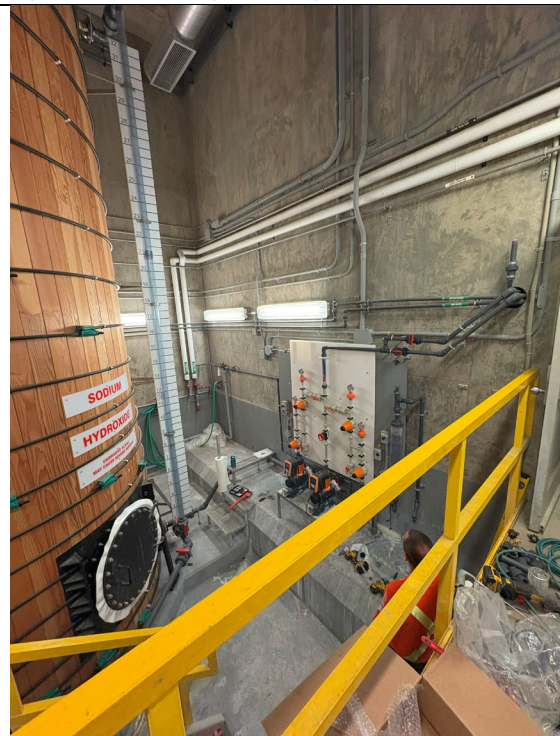
Figure 16: Sodium Hydroxide Pumps, Piping & Controls

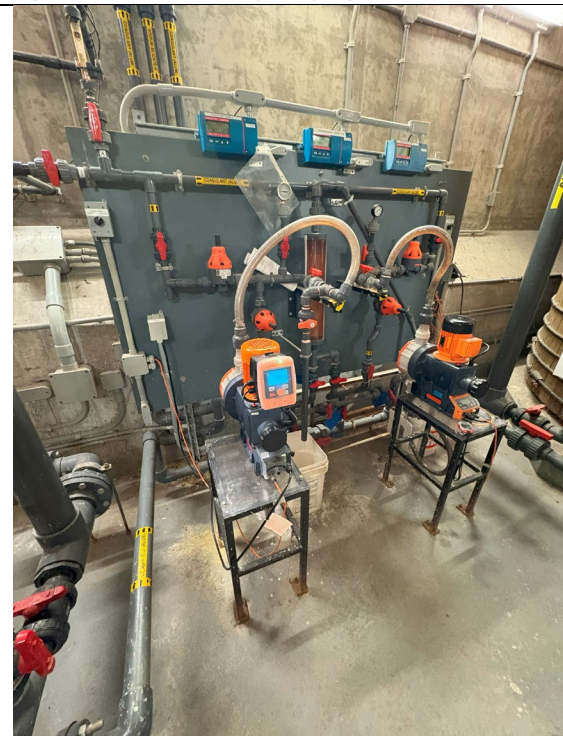
Figure 20: Coagulation Pumps Piping & Controls

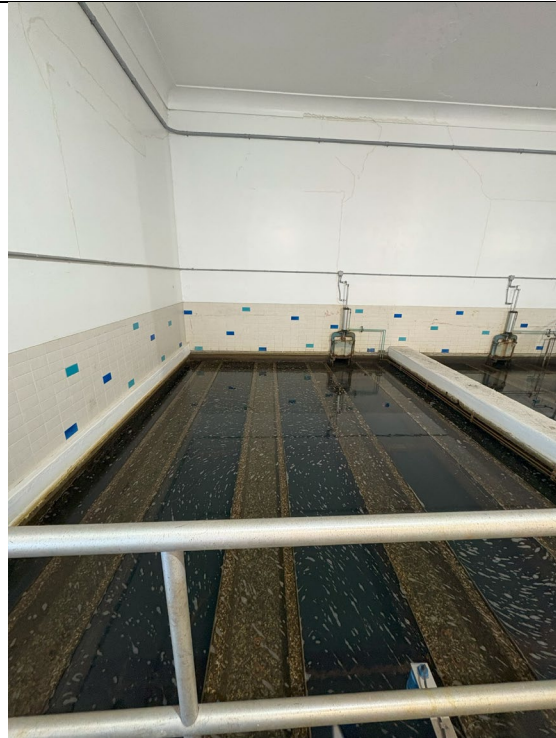
The Filter Bed Area in Plant #1 is very dated, with little upgrades to the filter bed area since its construction. At the time of inspection, the paint on the ceiling was peeling. It is recommended that the ceiling be repaired. The Filter Bed area in Plant #1 is in fair

Figure 29: Filter Gallery Ceiling in Need of Repairs

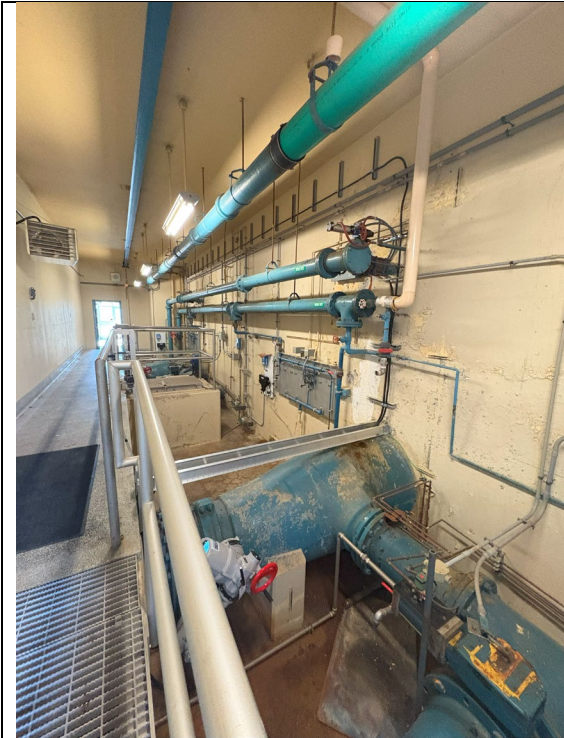
Figure 58: Plant #2 Pipe Gallery Paint Peeling

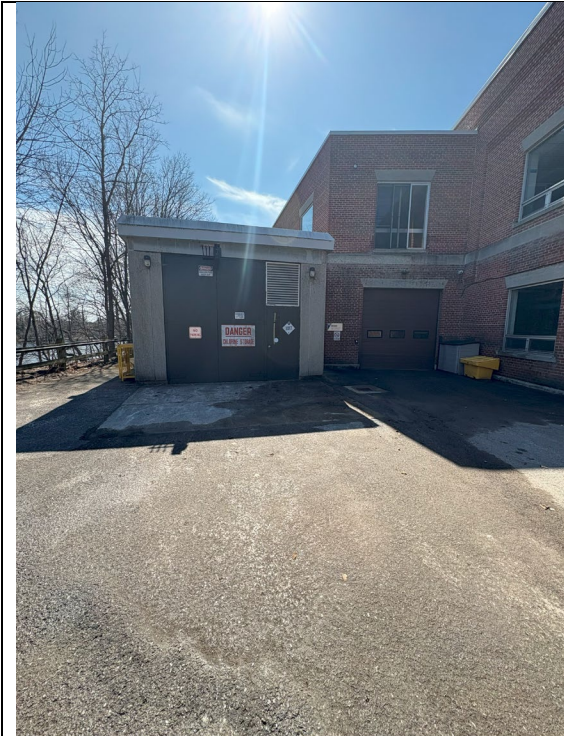
Figure 81: Chlorine Storage Building

The Chlorine Storage Building is adjacent to the water treatment plant. It is a brick, one story building on the East side of the main building. The Chlorine Storage Building can house up to 18 - 1 ton chlorine gas cylinders. The chlorine gas scrubber is located immediately to the south. No concerns were identified with the chlorine storage building or the chlorine injector room and are both in good condition.

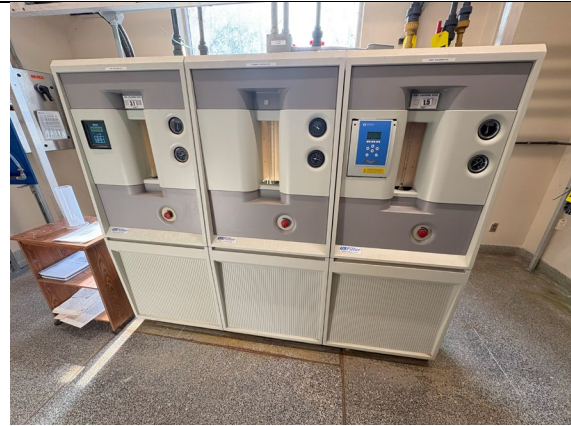
There are four (4) chlorinators located in the chlorine injector room. The chlorinators are for disinfection, back-up, post feed, and zebra-mussel control. The associated valves and injectors are in good condition.

Figure 85: Primary and Secondary Disinfection Chlorination

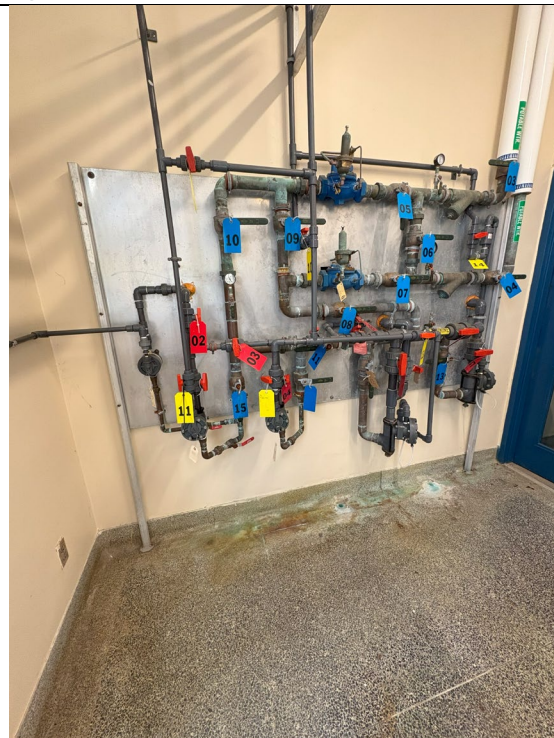
Figure 88: Chlorine Zebra Mussel Control

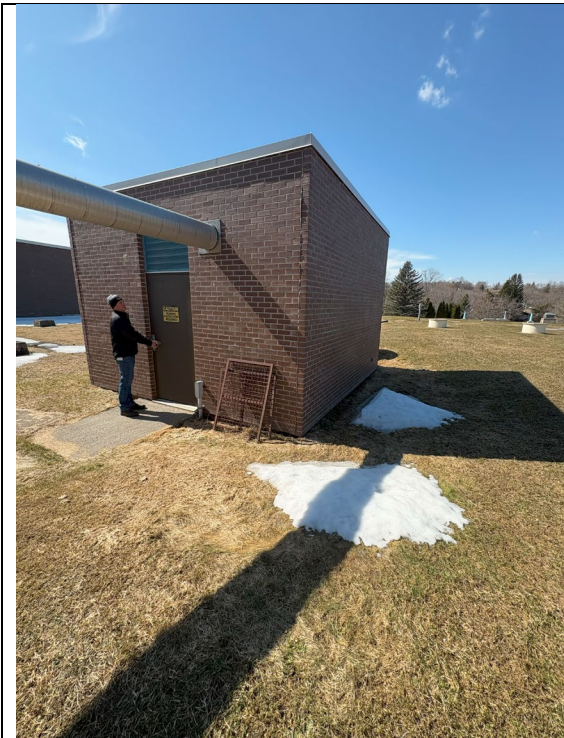
Figure 89: Blower Building Exterior

The Blower Building is adjacent to the water treatment plant Filter Gallery. It is a brick, one story building. The Blower Building houses air compressors and air scour filters. No concerns were identified with the blower building and it is in good condition.

An employee door is on the east side of the building with duct work protruding out the east side into the water treatment plant filter gallery. The brick facade of the building is in good condition and the roof was recently replaced. At the time of the inspection, no issues were noted, and the general condition is good.

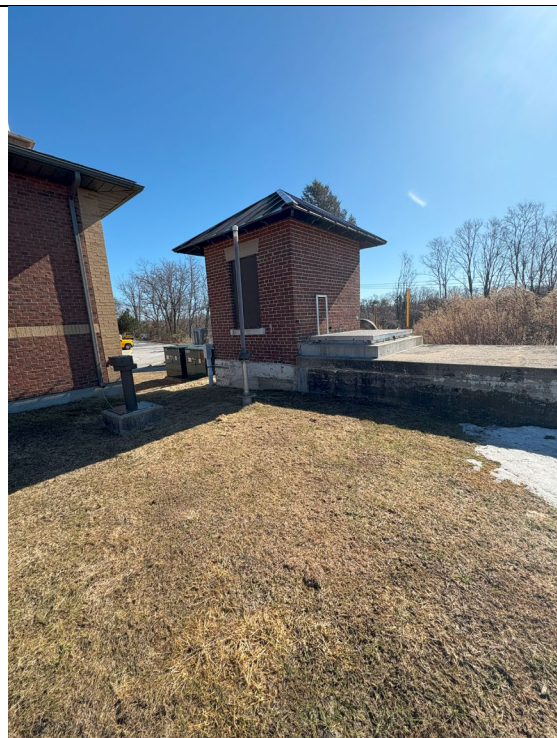
Figure 97: Chlorine Diffuser Building, New Roof

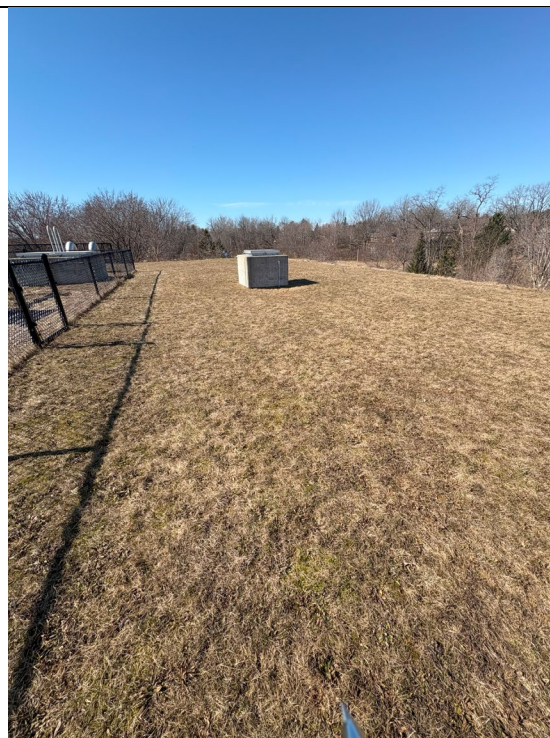
All process piping is below grade for the chlorine contact tanks and clearwells. No deficiencies were noted or observed, however most of the piping was not available for a physical inspection. CW#4 is currently not in use due to poor condition, it is recommended to have this fixed and cleaned prior to returning its use.

Figure 100: Access Hatch Clear Well #4

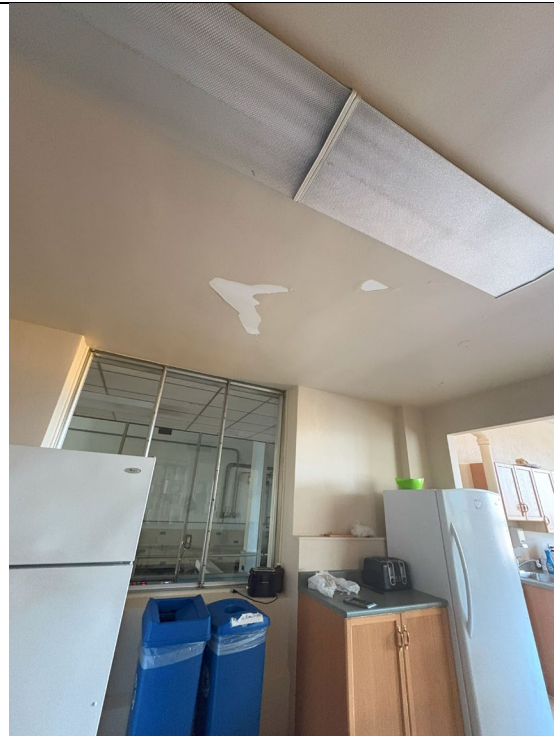
Figure 108: Employee Break Room, Peeling Paint

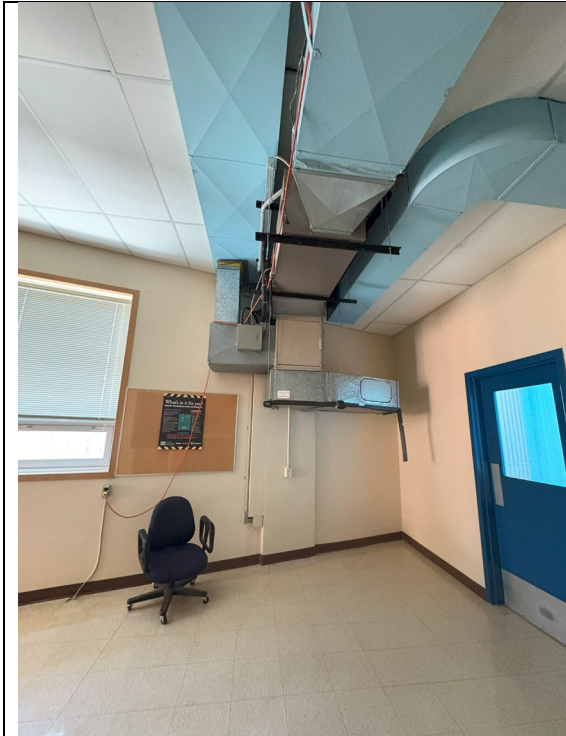
Figure 109: HVAC for Plant

The lighting throughout is provided by overhead fluorescent light fixtures. Heating and cooling are provided by a centralized HVAC system. At the time of inspection, all services related to the building appeared to be in fair condition.

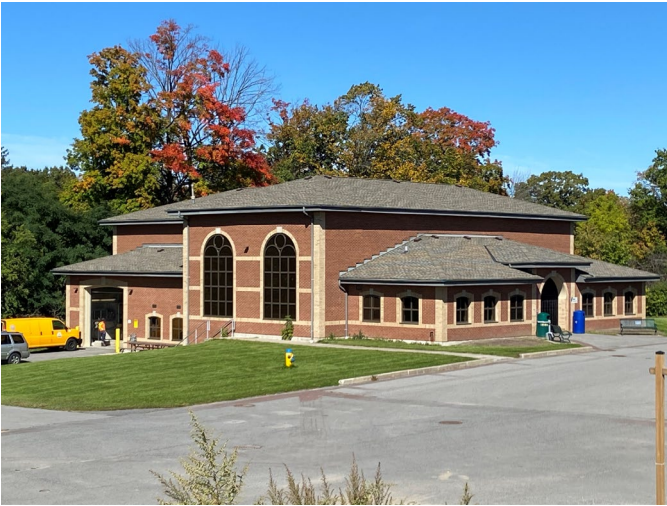
Figure 125: Exterior Eavestrough Bent

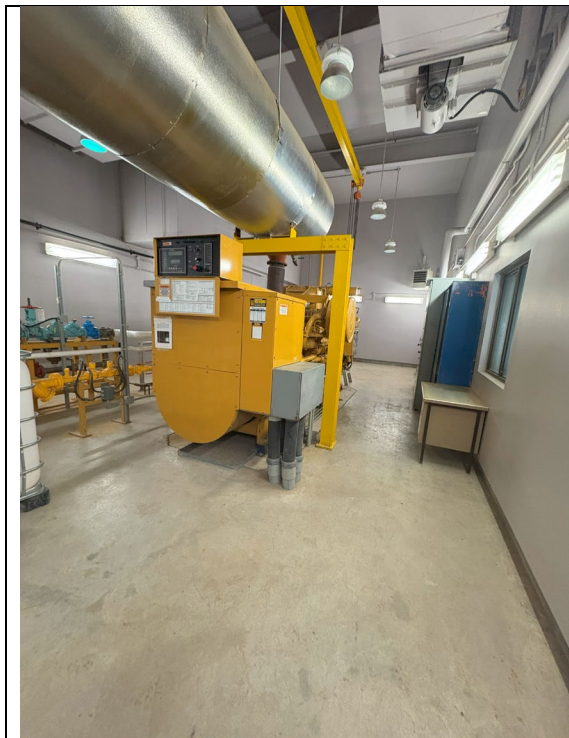
Figure 143: Caterpillar Motor with Generator Set

The Generator House located at the Peterborough Water Treatment Facility was constructed in 2000. The building houses a CAT G3516B, Natural Gas Fuel Generator Set. The generator operates at 990kW and is designed to provide emergency power to the Water Treatment Plant. The Generator House is located south of the main building and on the north side of the treatment plant's chlorine contact tank and clear wells. All building and process structural items were noted to be in excellent condition.

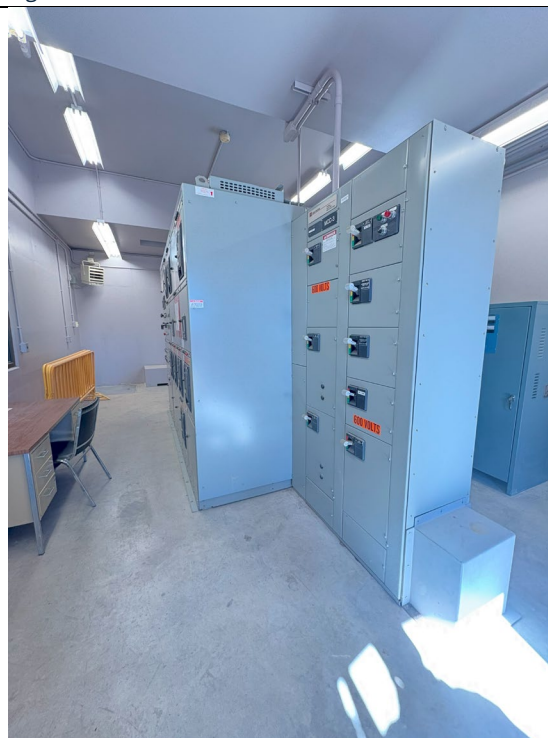
Figure 146: Electrical Switch Gear & SCADA

No deficiencies were noted with the electrical components at the time of the inspection, and all items were observed to be in good condition. Regular maintenance is completed on the facility and given the age of the facility no deficiencies were expected.

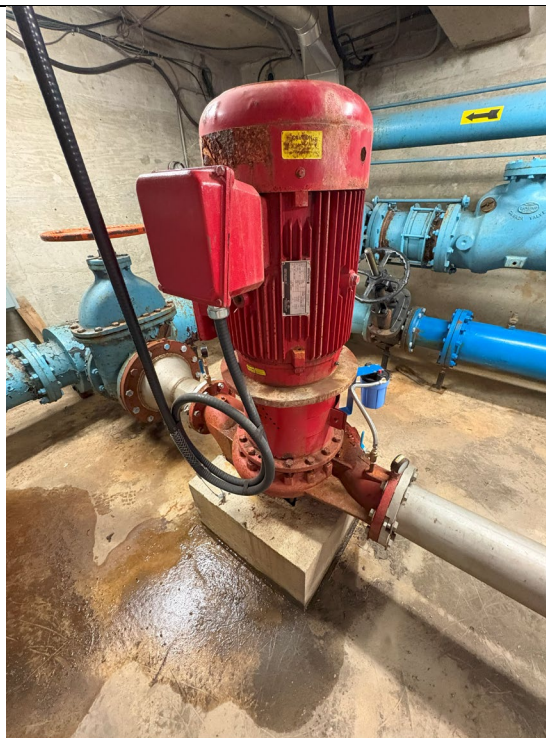
Figure 152: Pump #2

There is no generator in the station, and all gate valves, butterfly valves, check valves and air release valves are in good condition. Pump one (1) was replaced in 1991 and pump two (2) was replaced in 2009.

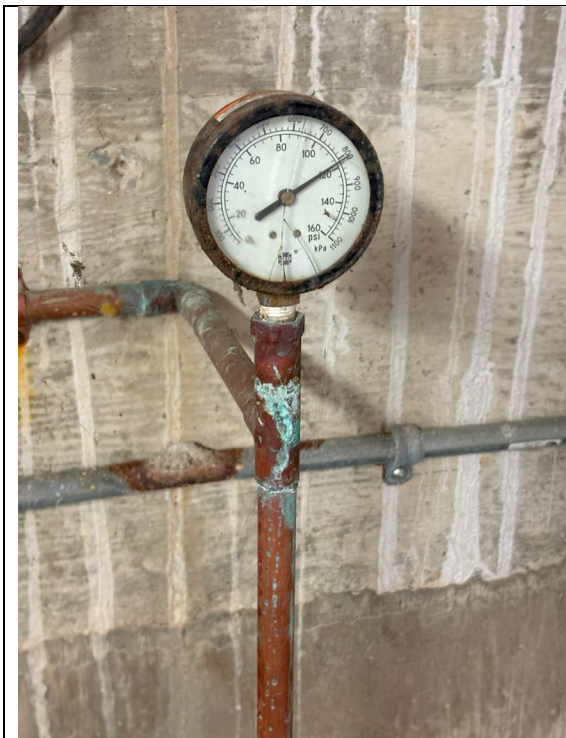
Figure 179: Discharge Pressure Gauge

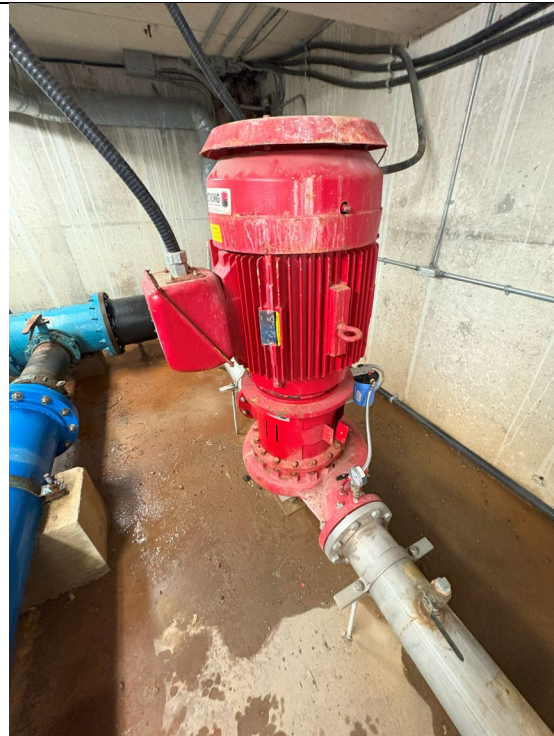
the pumps due to leaking, which could be improved with better drainage. The hatch is locked with a padlock. At the time of inspection, all services related to the building appeared to be in fair condition.

Figure 186: Pump #1

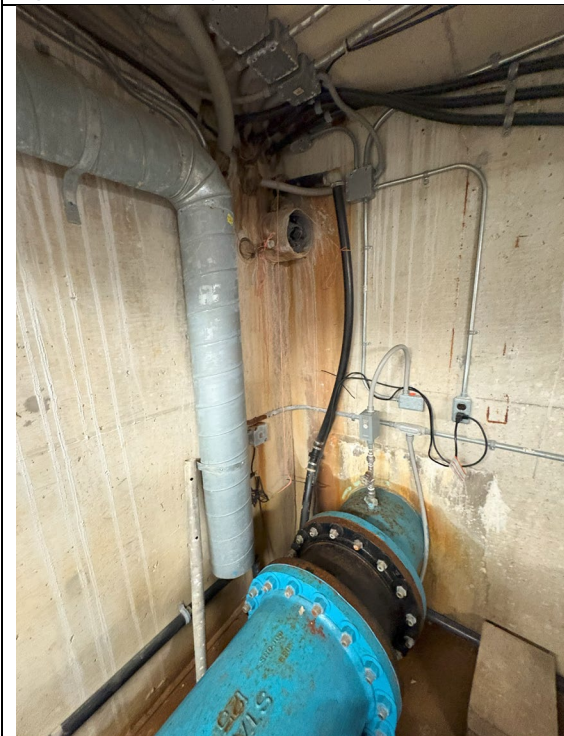
Figure 189: Southwest Corner of Station

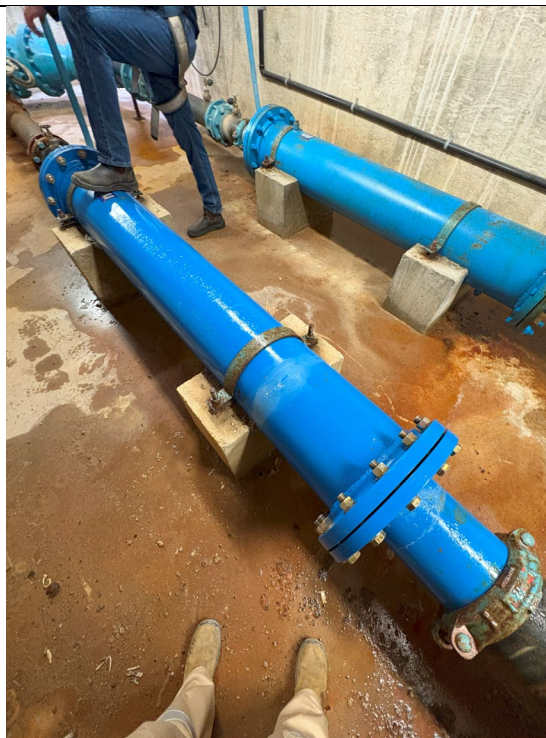
Figure 192: Inline Pumps

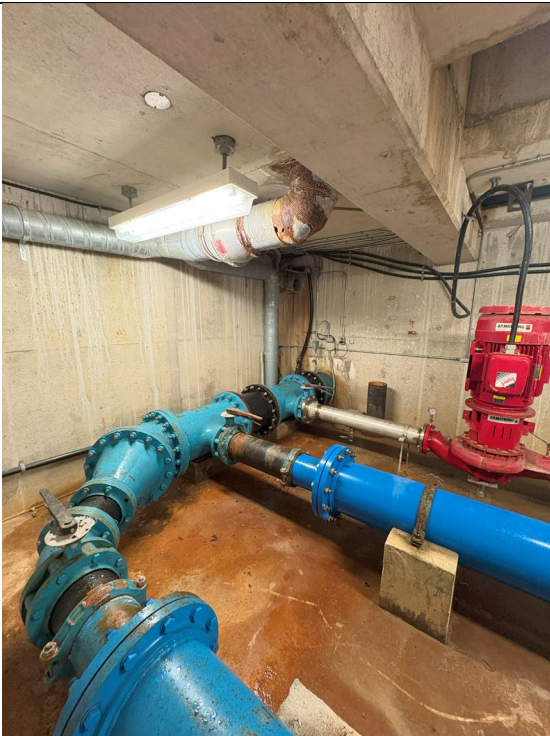
No deficiencies in power supply, lighting, or heating were observed in the station. The duct work for the ventilation system was found to be in poor condition due to severe corrosion and section loss, it is recommended this is repaired. There were puddles of water below

Figure 205: Northwest Corner, Ventilation Needs

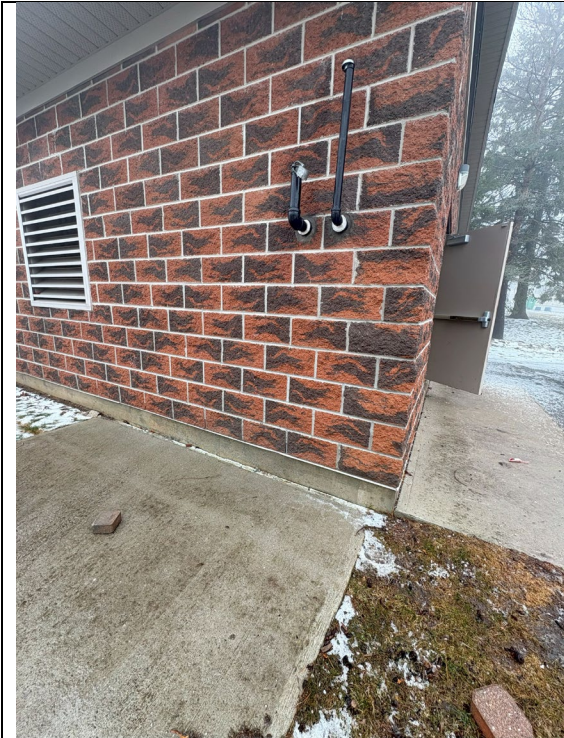
This site is located at the east/west midpoint of Cumberland Ave, at the north entrance of the Parkway Trail. There is no fence surrounding the property for security purposes as it is in a residential neighbourhood. The site generally drains away from the building to the north, east and south. A cutoff swale along the west side directs surface runoff away from the building. There are a few mature trees on the site. The asphalt driveway and parking lot are in good condition. The remainder of the site is sodded with regular lawn cutting being completed by a third-party vendor. The fuel filling station for the generator is quite high and is recommended to install concrete steps to make fueling for Upper Canada easier.

Figure 211: Generator Fueling Station

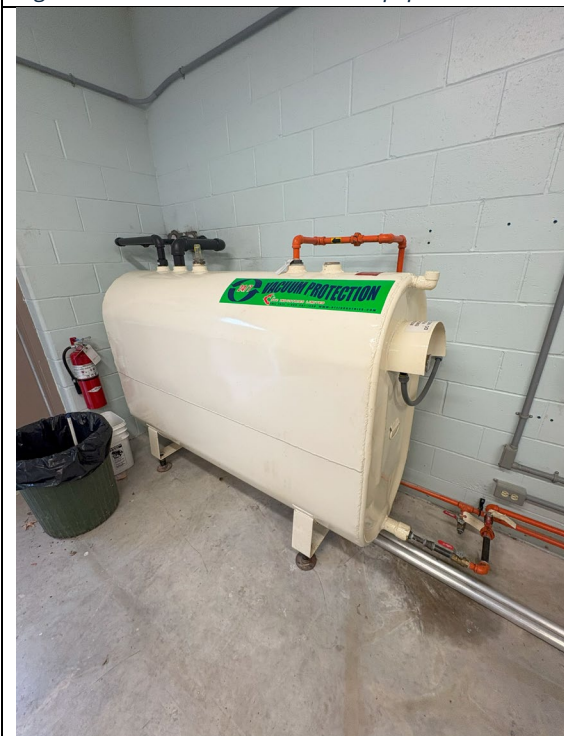
Figure 217: Fuel Tank in Northeast Corner

The station has a diesel generator and fuel tank, which are used to supply power to the pumps in the event of a power outage. The generator is inspected annually by a third-party vendor. The generator is in good condition and does not need to be replaced. A safety guard has also been installed. All gate valves, butterfly valves, check valves, and air release valves are in good condition.

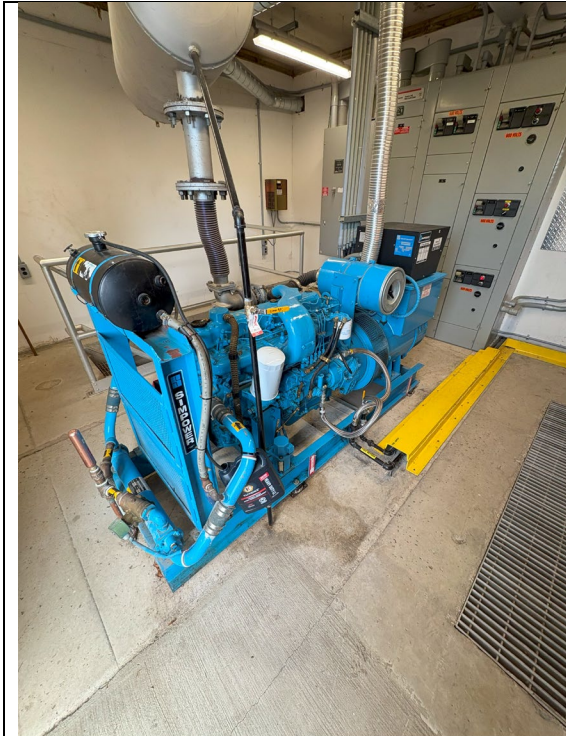
Figure 242: Generator

The station has a diesel generator, which is used to supply power to the pumps in the event of a power outage. The generator is in good condition and does not need to be replaced. All gate valves, butterfly valves, check valves, and air release valves are in good condition.

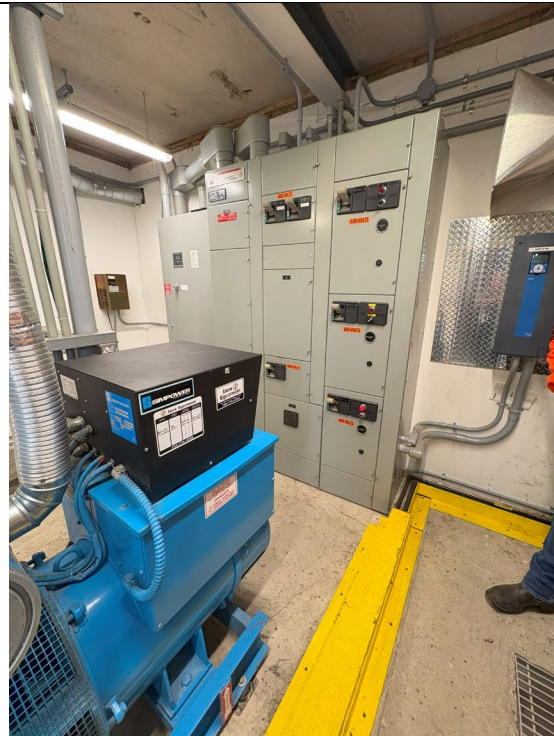
Figure 245: SCADA and Electrical Equipment

All SCADA components are in good condition and do not need to be replaced.

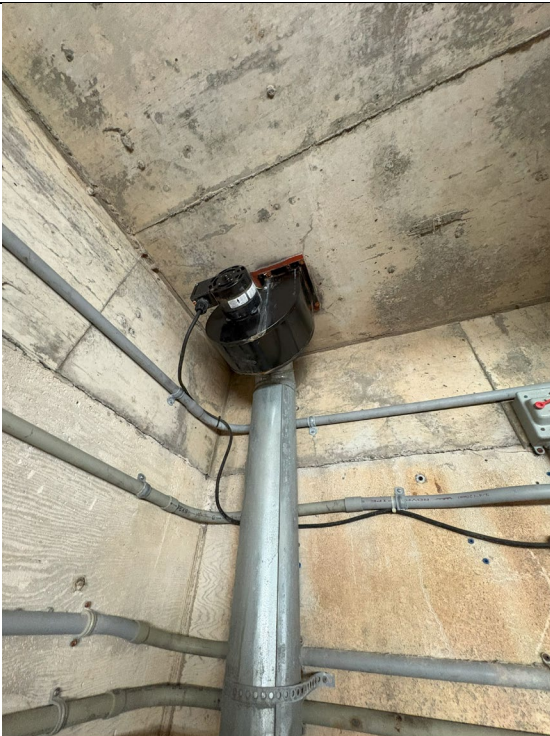
Figure 304: Ventilation

No deficiencies in power supply, lighting, or heating were observed in the station. The only form of ventilation in the station is the hatch, which provides minimal airflow. It is recommended to install a ventilation system as the humidity is causing early corrosion of equipment. The hatch is locked with a padlock. At the time of inspection, all services related to the building appeared to be in fair to good repair.

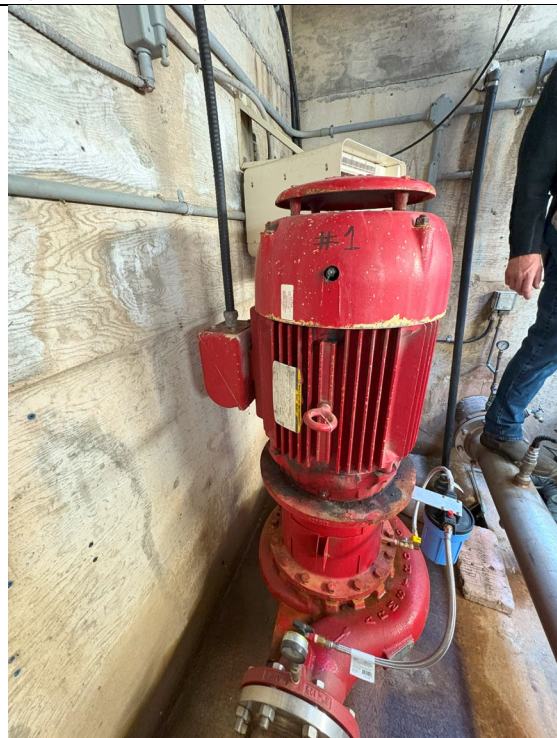
Figure 308: Pump #1

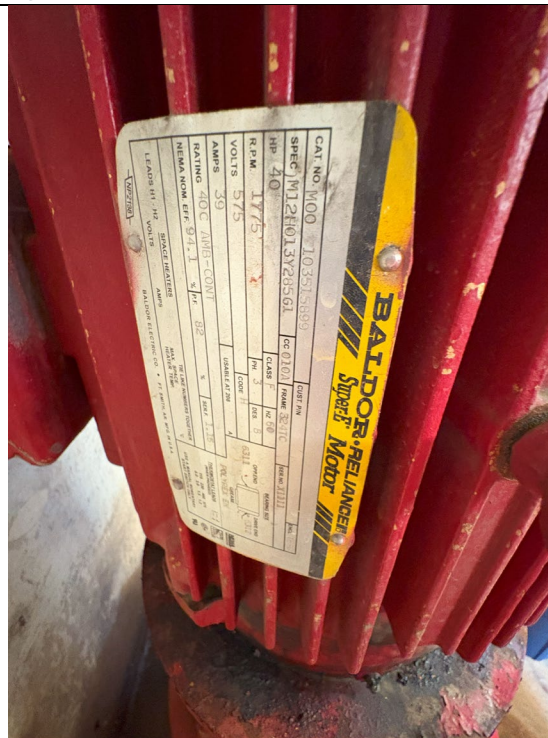
Figure 309: Label on Pump #1

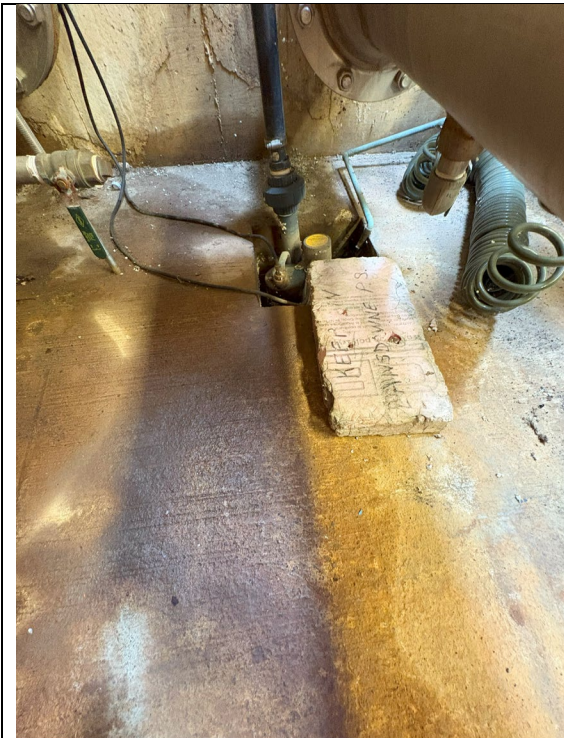
Figure 310: Sump Pump

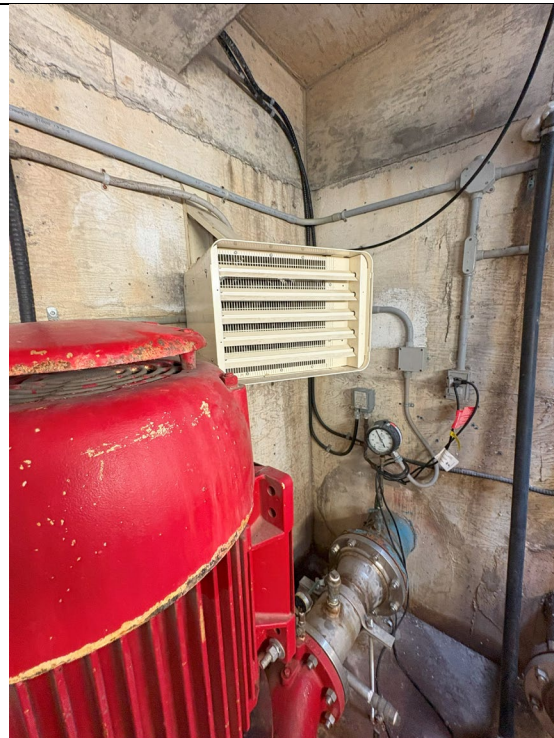
Figure 311: Ventilation

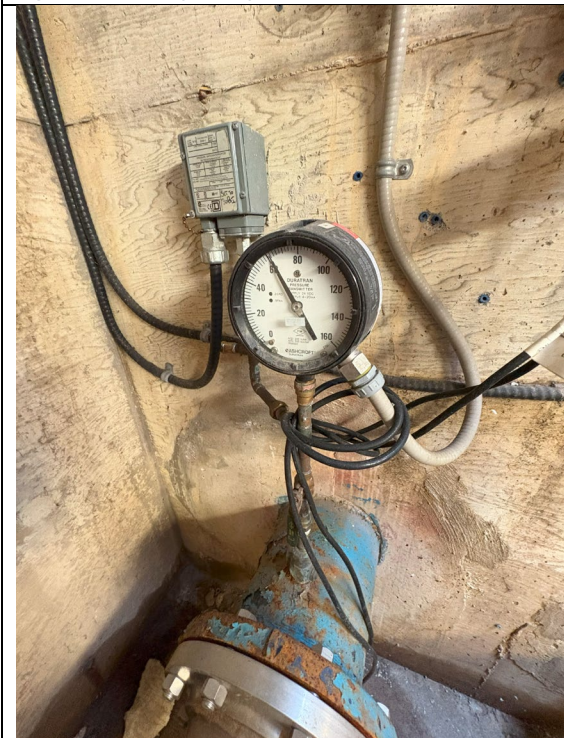
Figure 312: Suction Pressure Gauge

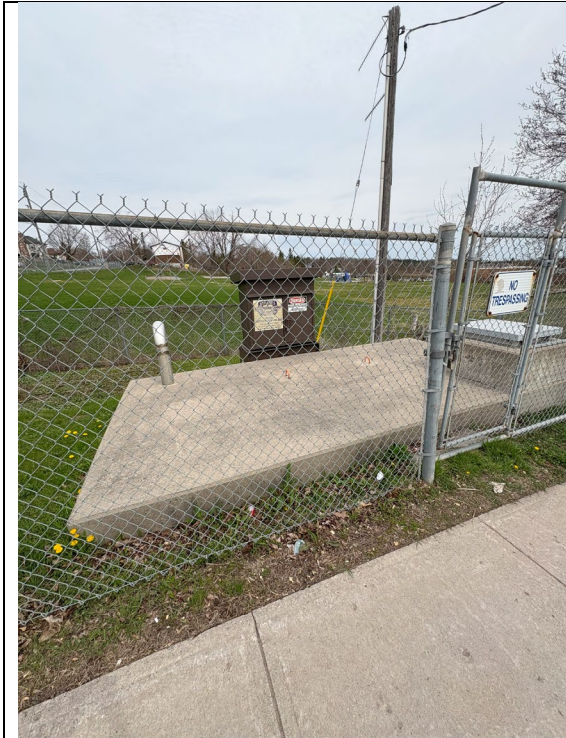
Figure 314: Access Hatch and Fence

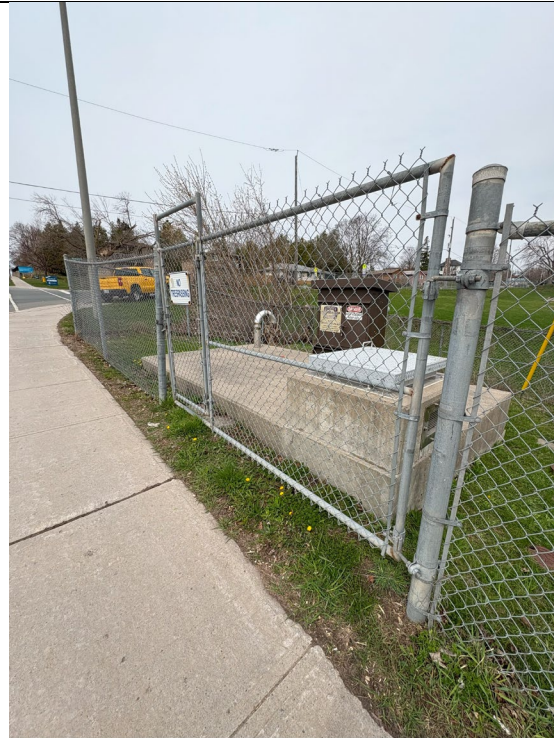
Figure 315: Access Hatch and Fence Facing West

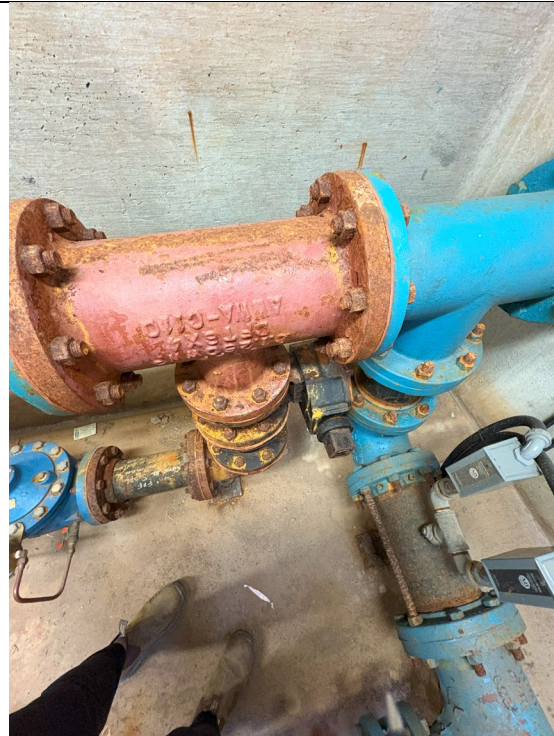
All pipes and bends are in fair condition. Where a pump or valve has been replaced, stainless steel spool pieces have been fabricated. The station is functioning satisfactorily, and it is not recommended that the pipes be replaced. No deficiencies were observed at the time of the inspection.

Figure 321: Pipe Along North Wall

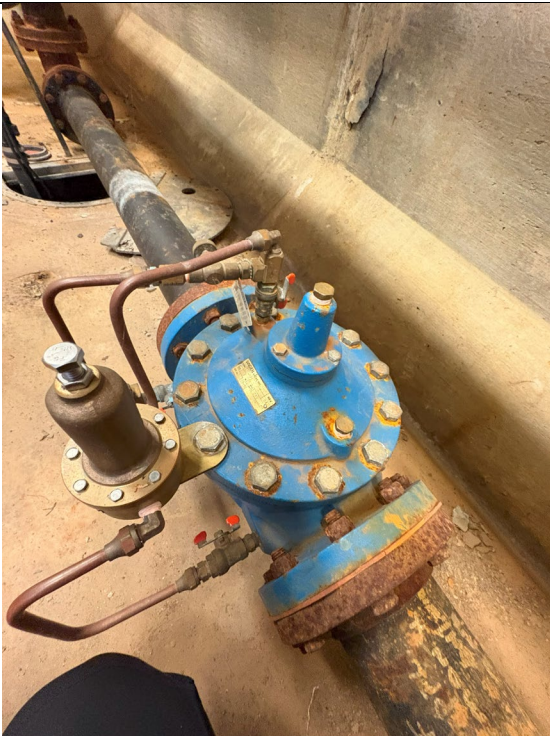
Figure 322: 6" Pressure Reducing Valve

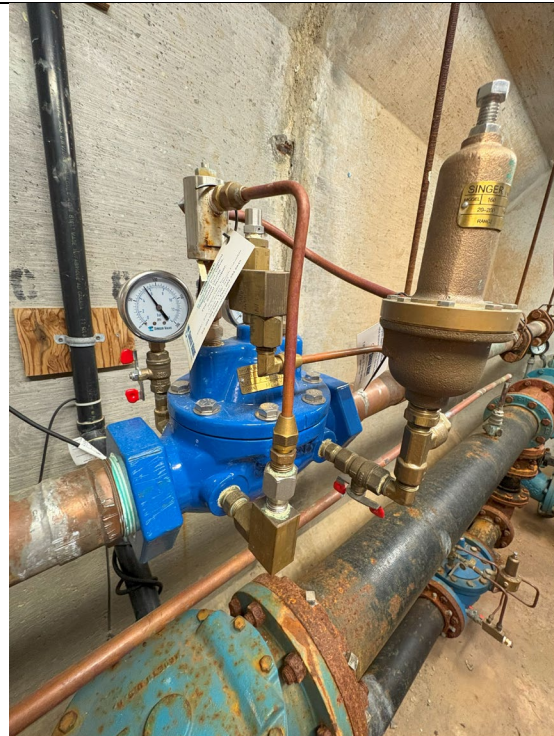
Figure 323: 2" Pressure Reducing Valve

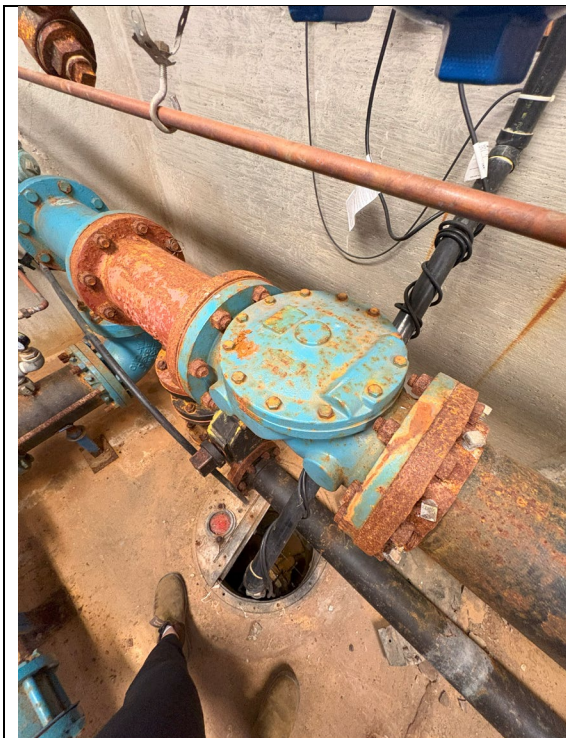
There is no generator in the station, and all gate valves, butterfly valves, and check valves are in fair condition.

Figure 324: Check Valve on By-Pass

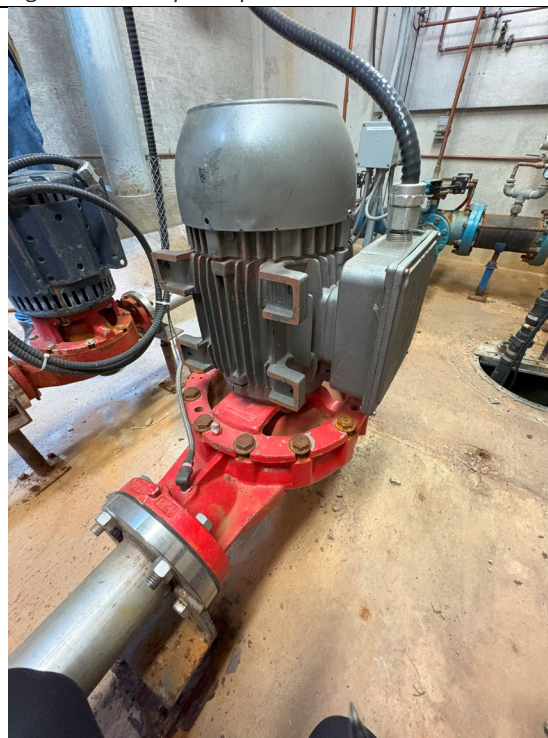
Figure 327: Pump #1

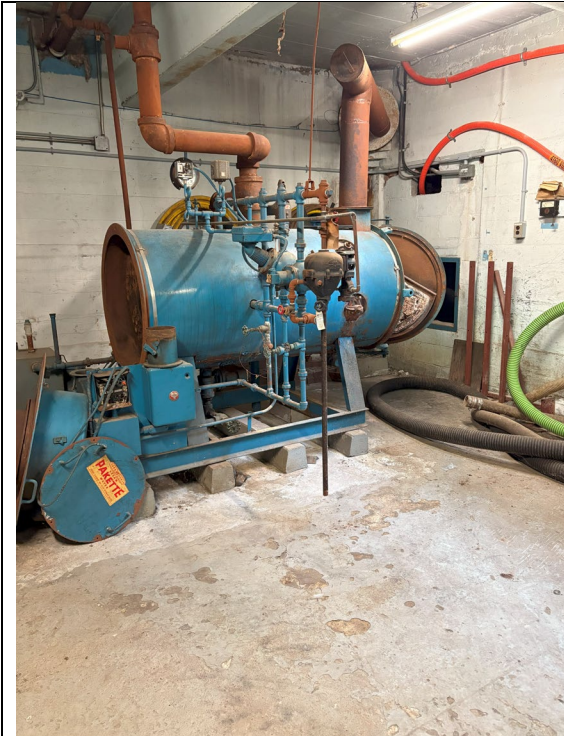
Figure 342: Equipment Being Removed

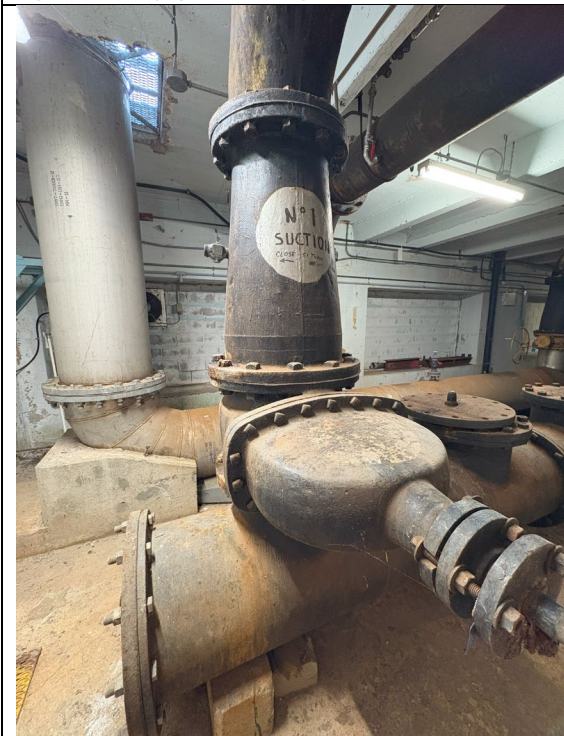
The pumps, turbines, waterwheels, gear increasers, and gear decreasers are all in working condition, however they are at the end of their serviceable design life. Pump one (1) and two (2) were installed in 1945. Pump four was installed in 1935. The age of pumps three (3) and five (5) are unknown. The generators are in fair condition. The gate valves, butterfly valves, and check valves have some discolouration and surface rust due to age and environmental factors. The process mechanical equipment is in poor to fair condition.

Figure 344: Pump #1 Suction Gate Valve

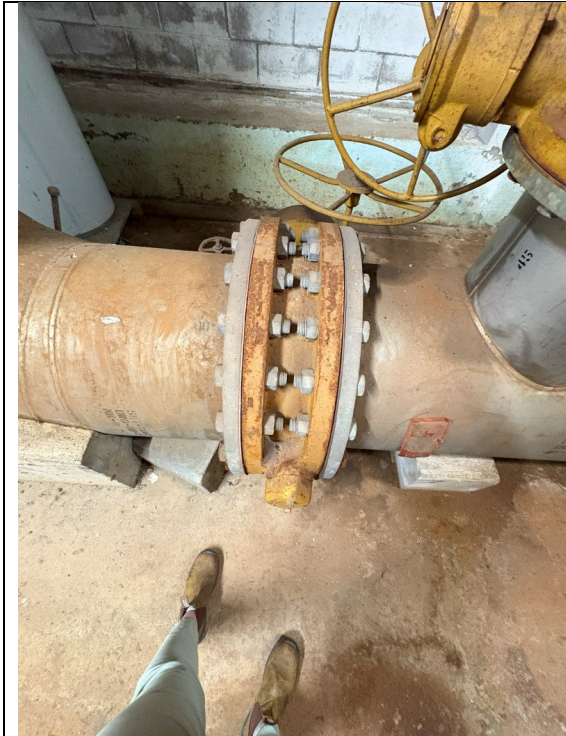
Figure 346: Pump #1 Butterfly Valve

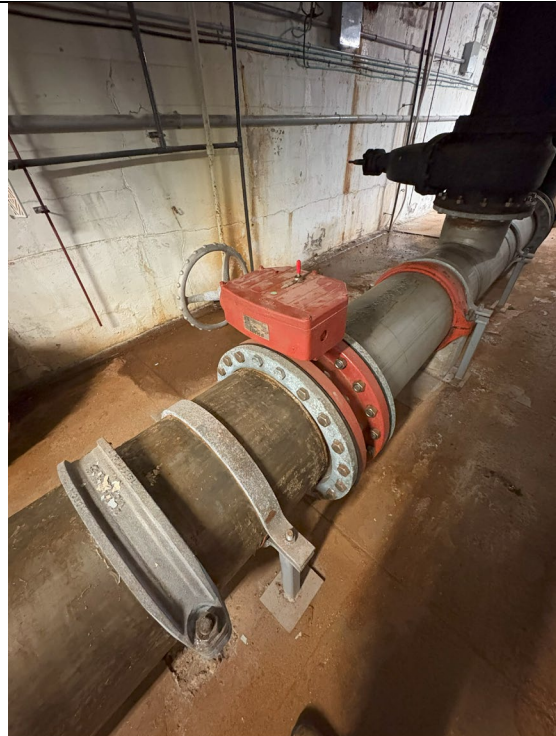
Figure 353: Pump#3 Suction Gate Valve (labelled incorrectly)

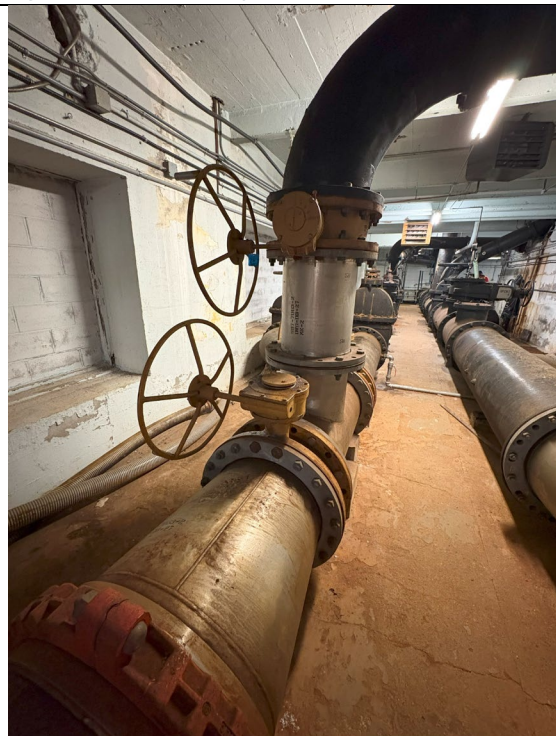
Figure 355: North Wall Historical Emergency Inlet Capped
