2025

Asset Management Plan Water Services
The Corporation of The City of Peterborough

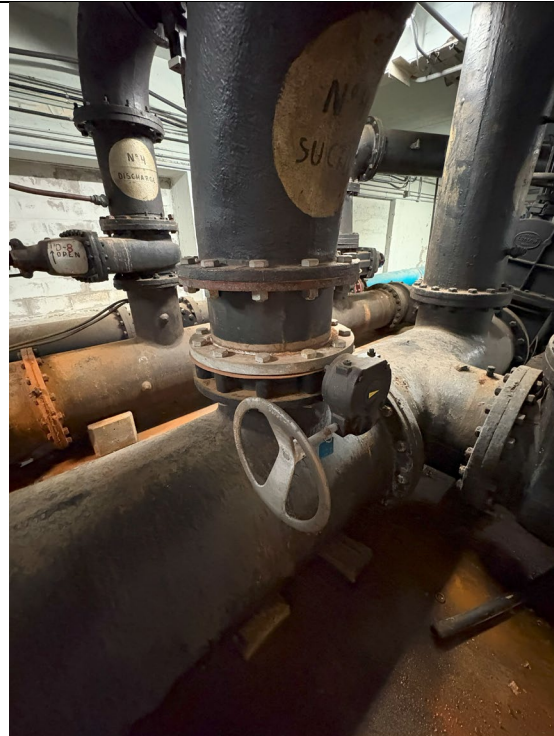
Figure 373: Out of Use Gate Valve

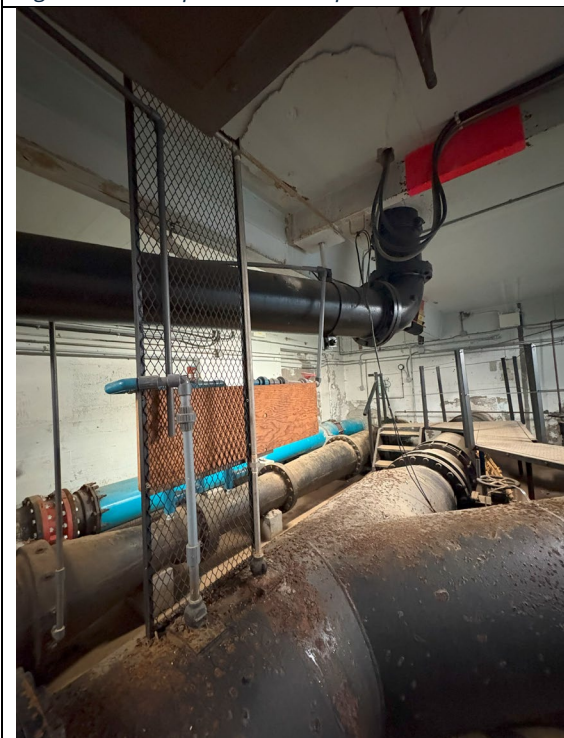
Figure 386: Pump #5 Discharge Piped

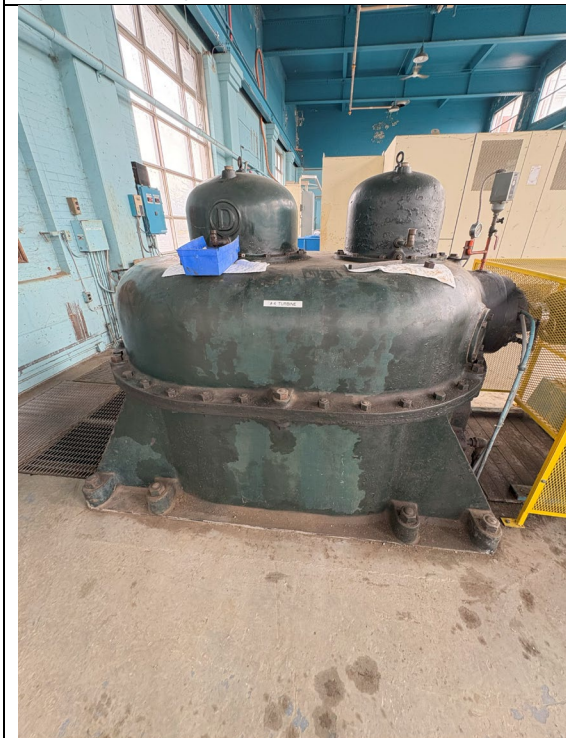
Figure 398: Pump #4 & Generator (can be setup as a motor)

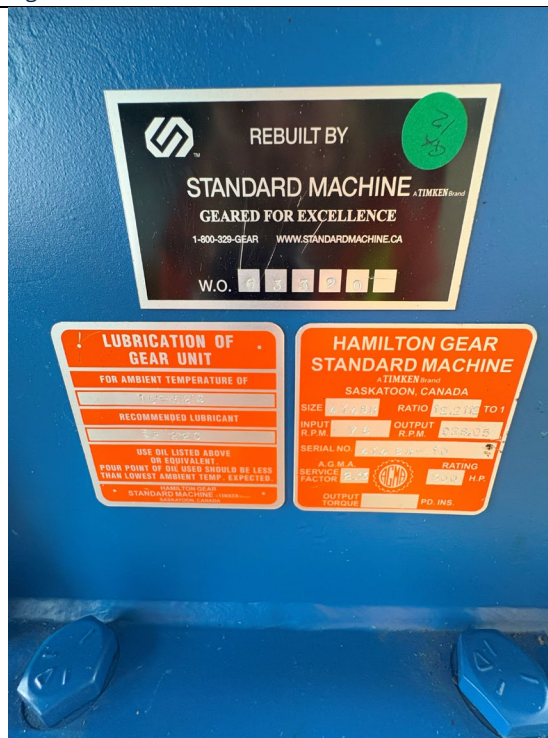
Figure 407: Generator #3 Gearbox, Recently Rebuilt

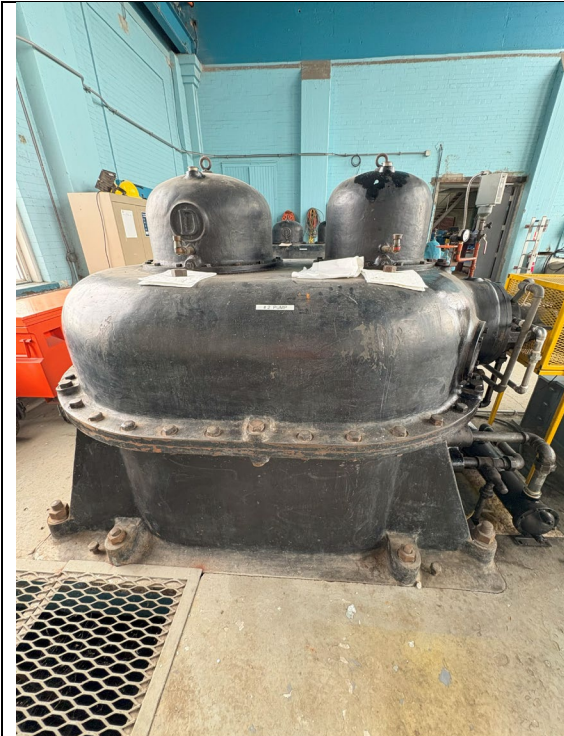
The pumps, turbines, waterwheels, gear increasers, and gear decreasers are all in working condition, however they are at the end of their serviceable design life. Pump one (1) and two (2) were installed in 1945. Pump four was installed in 1935. The age of pumps three (3) and five (5) are unknown. The generators are in fair condition. The gate valves, butterfly valves, and check valves have some discolouration and surface rust due to age and environmental factors. The process mechanical equipment is in poor to fair condition.

Figure 416: Pump #2 & Motor

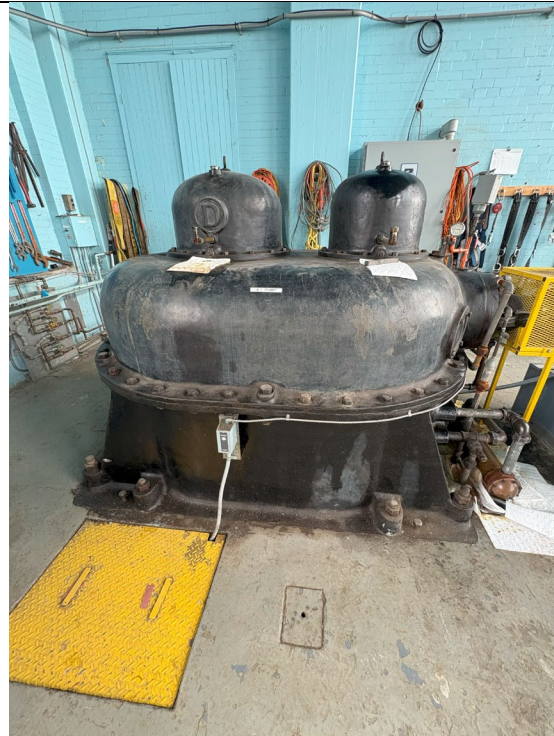
Figure 421: Pump #1 and Motor

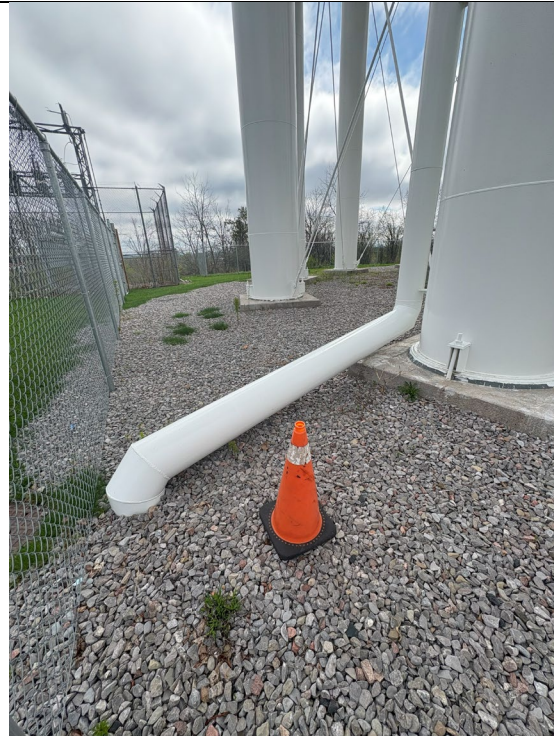
Figure 438: Drainpipe

The tower is fed with a 500mm stainless steel pipe and is in good condition. A new 500mm gate valve was installed in 2021. There is a defect in the drainpipe, resulting in a consistent leak. The drainpipe requires repairs.

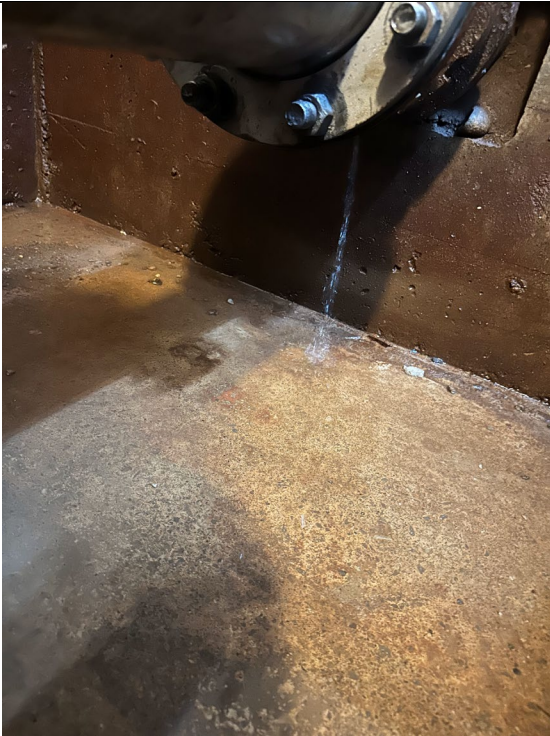
Figure 441: Defect in Drainpipe, Constantly Leaking

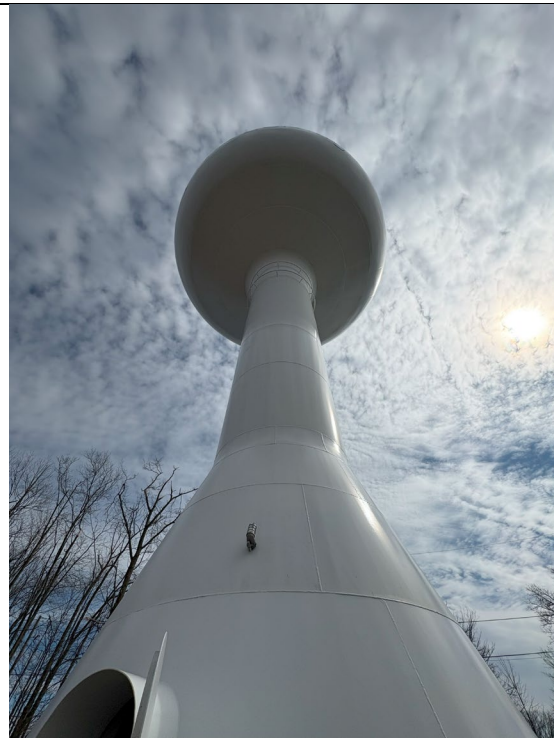
Figure 470: Exterior Coating on Tower

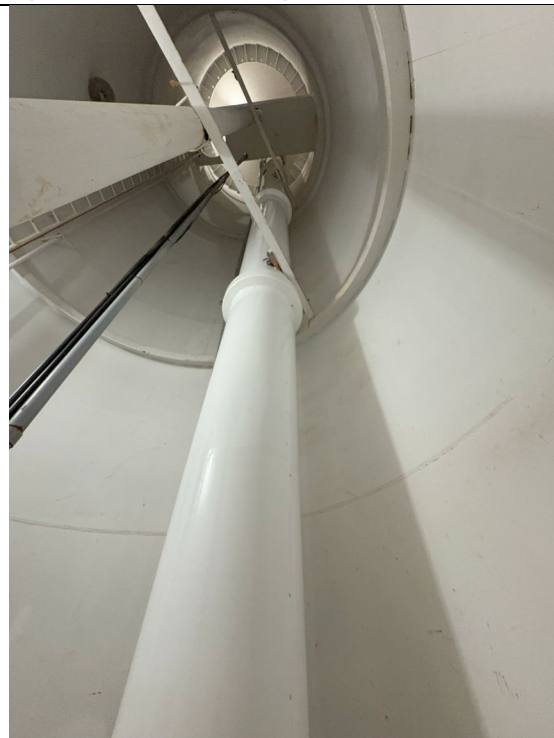
Figure 472: Process Piping

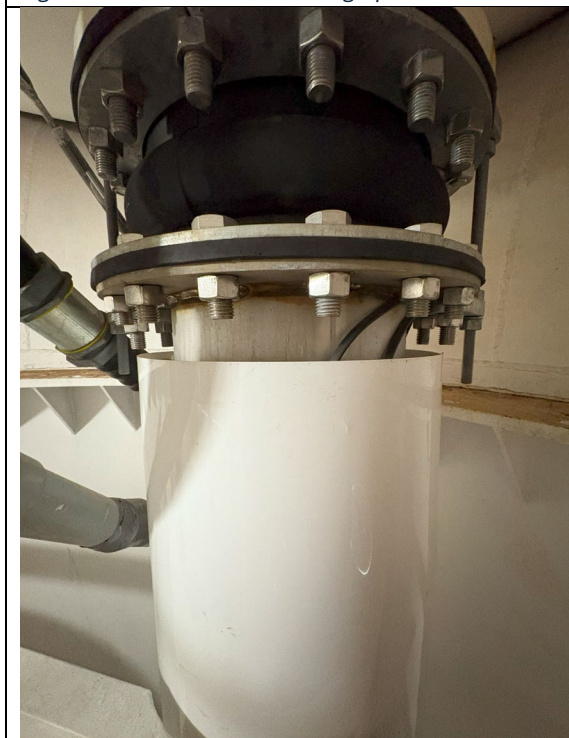
The tower is fed with a 450mm stainless steel pipe, which is insulated, and is in good condition. At the time of the inspection, the insulation appeared in good condition.

Figure 479: Process Piping Insulation

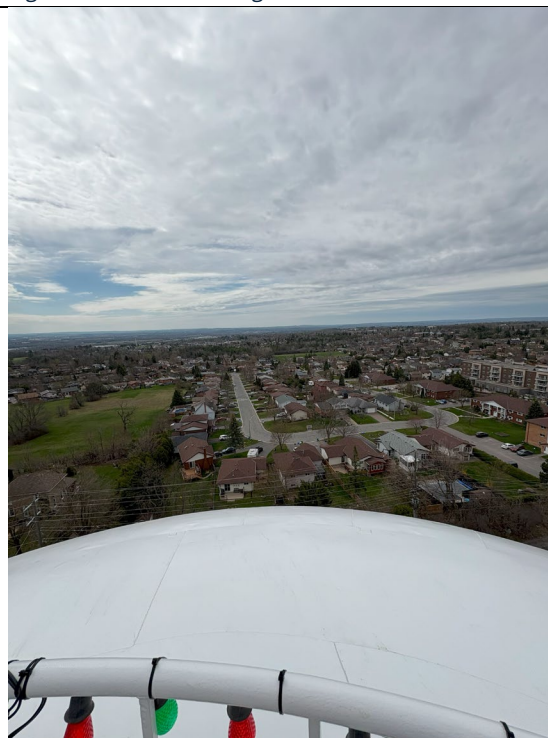
Figure 480: Exterior Coating

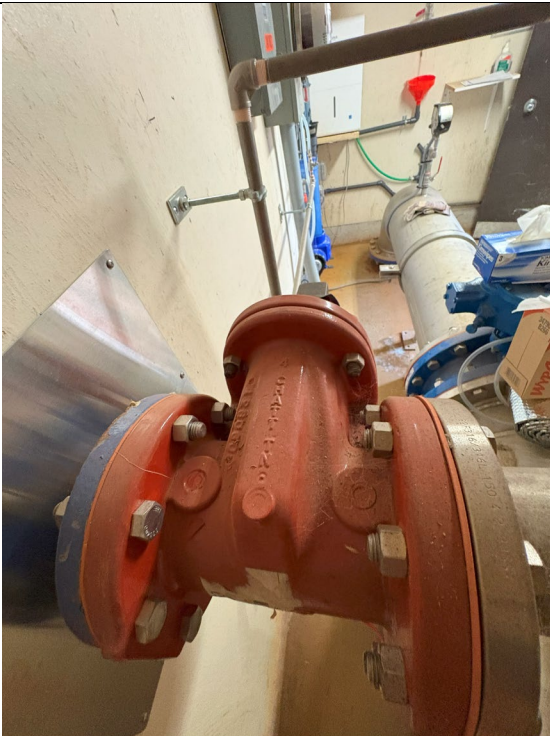
Inside the valve room there is a sump pump, and it appears to be in good condition. The butterfly and gate valves are in good condition.

Figure 503: Gate Valve

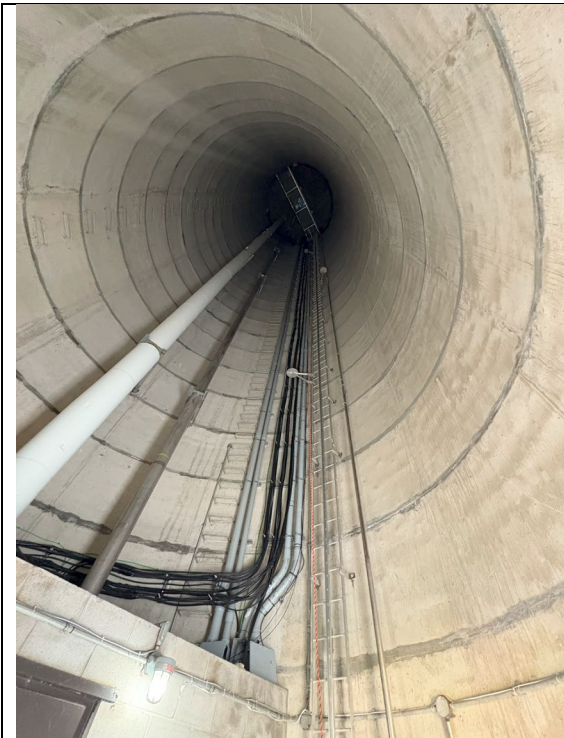
The tower is fed with a 300mm inlet pipe and is in good condition. At the time of the inspection, the insulation around the pipe appeared adequate.

Figure 508: Looking up the Tower Inside, 12" Pipe Feed

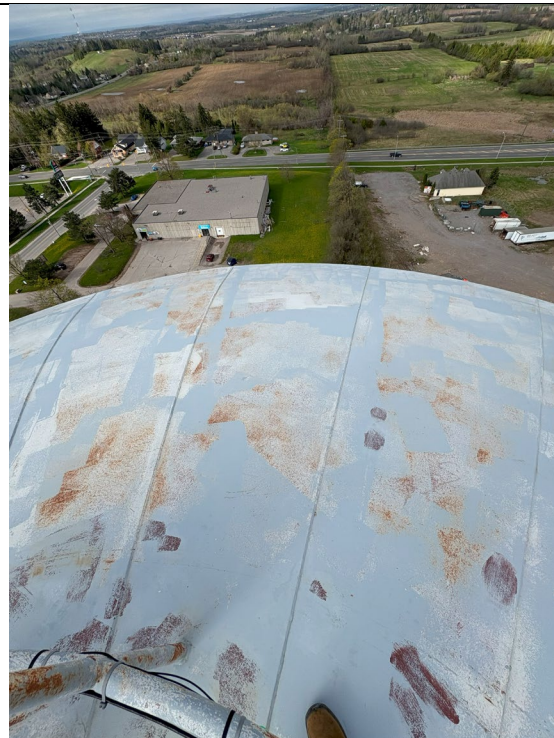
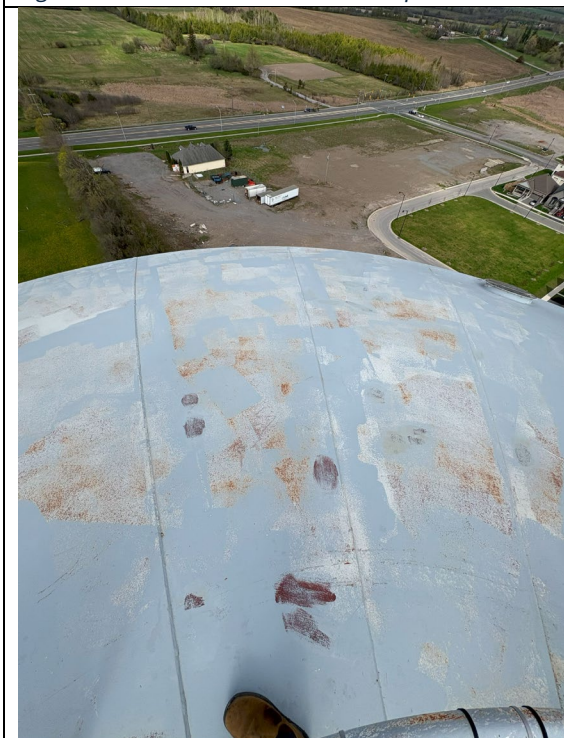
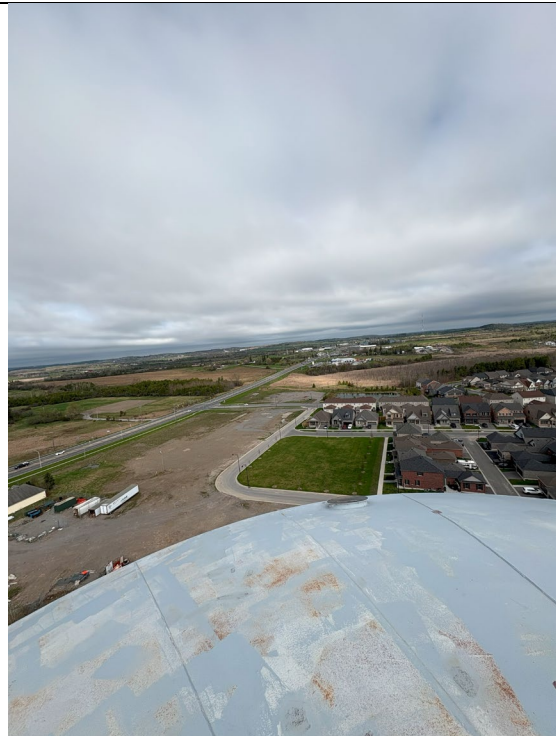
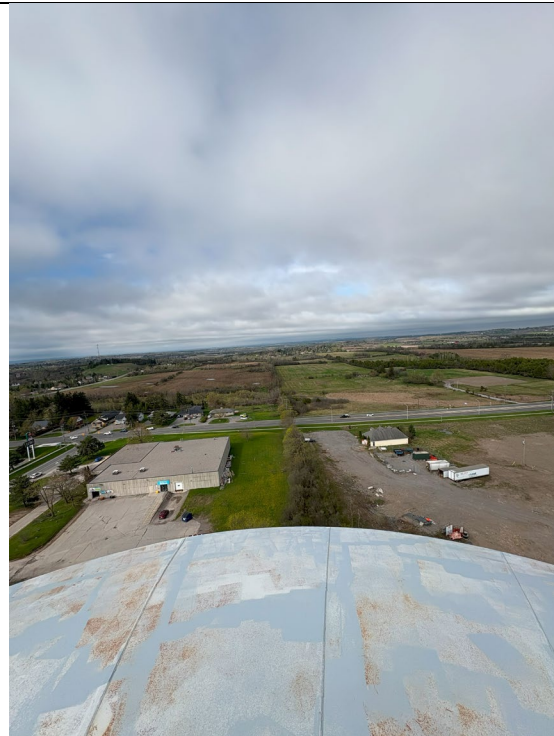
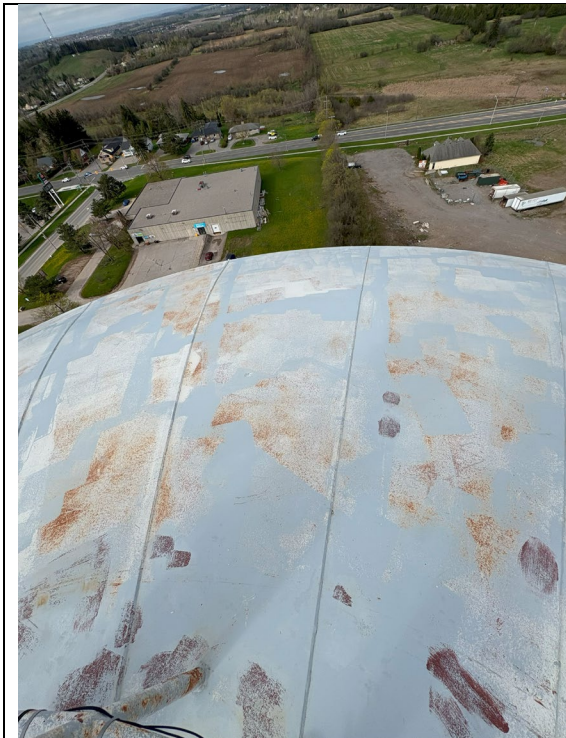
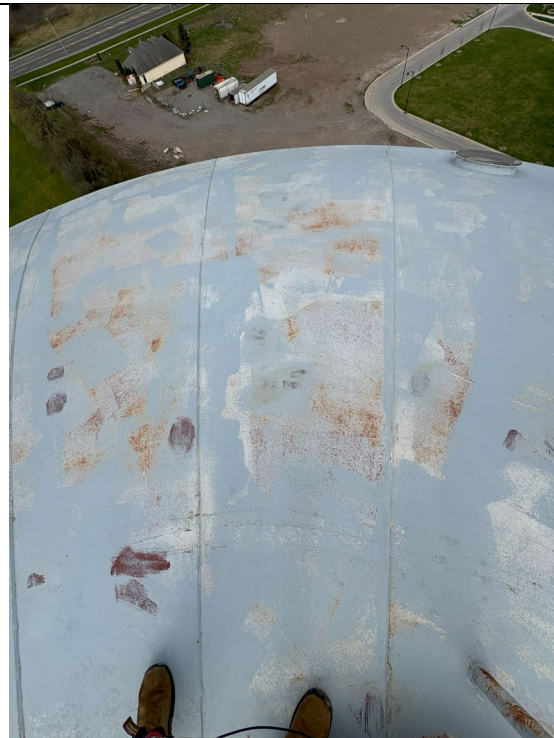
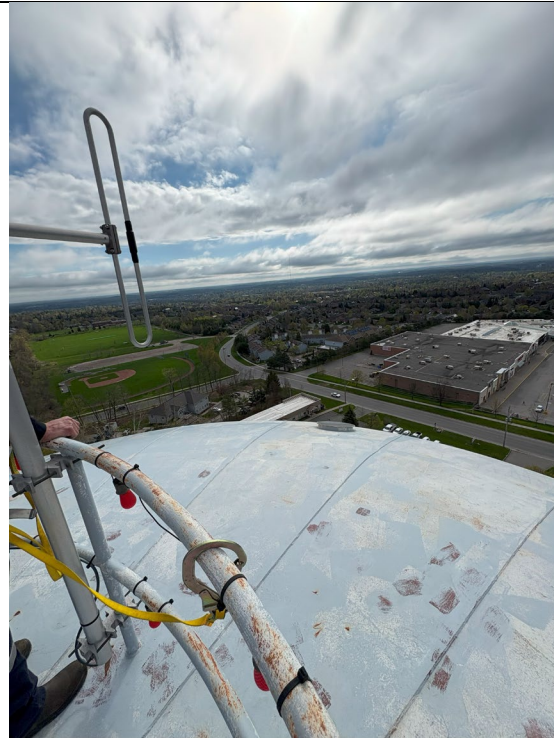
The pedestal is constructed of cast in place concrete. Each ring is a meter tall and has a diameter of 6.1 meters. The exterior is an industrial finish. The tank (storage cell) is a steel structure. Upon inspection the tanks exterior coating was observed to be in poor condition with corrosion occurring. There is a tree line to the north and west of the tower, which does not interfere with the tower. There is a paved driveway leading to the base of the tower. On the north and east sides of the tower, there is electrical equipment, including transformers and communication equipment for the multiple cellular network antennas and satellite dishes (Rogers and Freedom Mobile). The communication antennas are attached to the top portion of the pedestal, below the tank.

Figure 517: Exterior Coating

The Milroy Elevated Tank is a composite water tank and the newest water tower in Peterborough. Since its construction in 1987, no changes have been made to the tower or water tank other than routine maintenance and cleaning. All equipment is above grade at the base of the tower. The inlet/outlet pipe is a 300mm ductile iron watermain. The structure appears to be in fair to good condition and no concerns were identified, however it is known that the interior of the tank is exhibiting signs of corrosion. An internal inspection was performed by Loftin Enterprises in April 2024 to verify the tank condition. The findings from this inspection were complete removal and replacement of the coating / lining systems coupled with steel inspection and remediation is recommended.

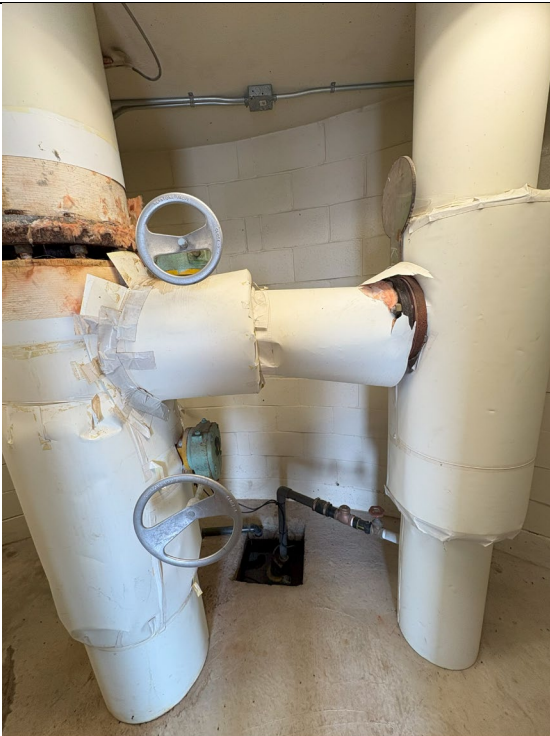
Inside the valve room there is a sump pump, and it appears to be in good condition. The two (2) butterfly valves are wrapped in insulation. The valves are in fair condition with limited inspection due to insulation.

Figure 534: Two Butterfly Valves on 12" Feed

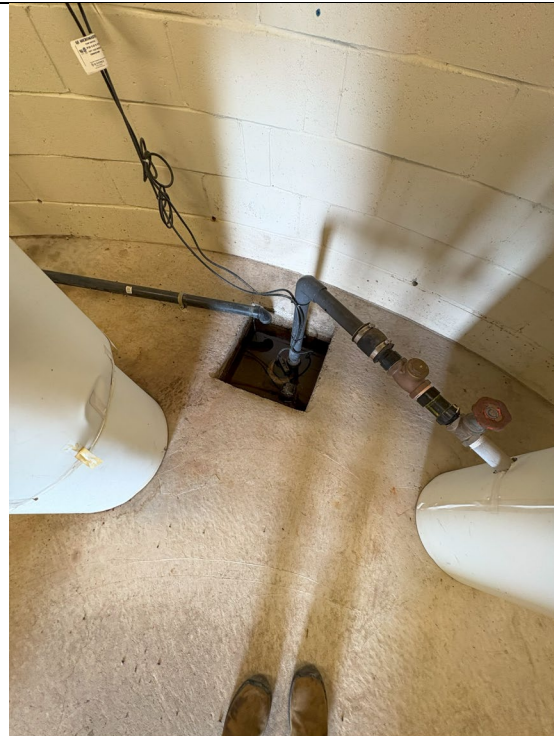
Figure 535: Sump Pump

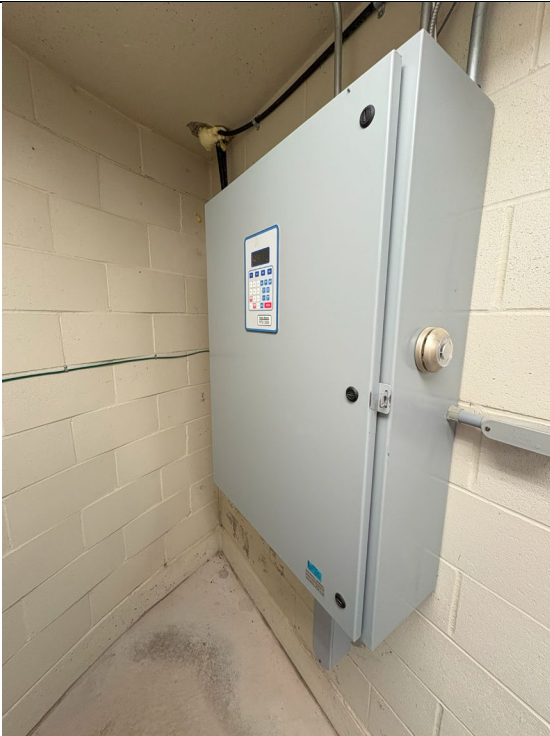
All SCADA components are in good condition and do not need to be replaced.

Figure 536: SCADA Control Box

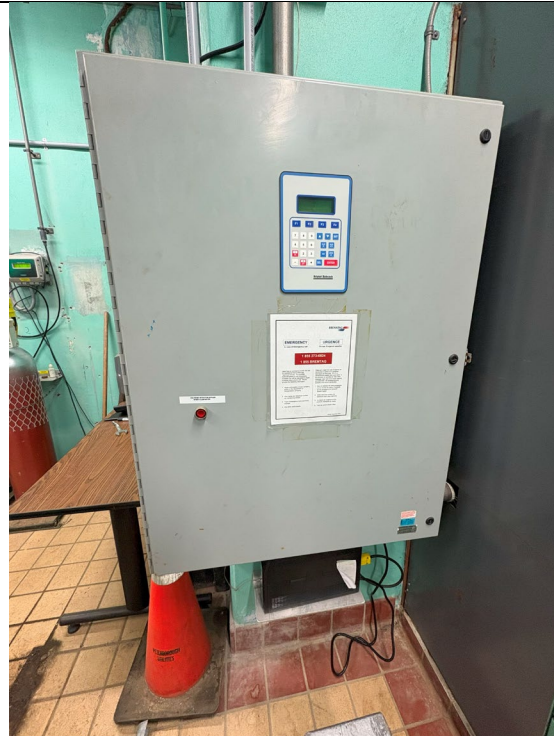
All SCADA components are in good condition and do not need to be replaced.

Figure 544: SCADA Control Box

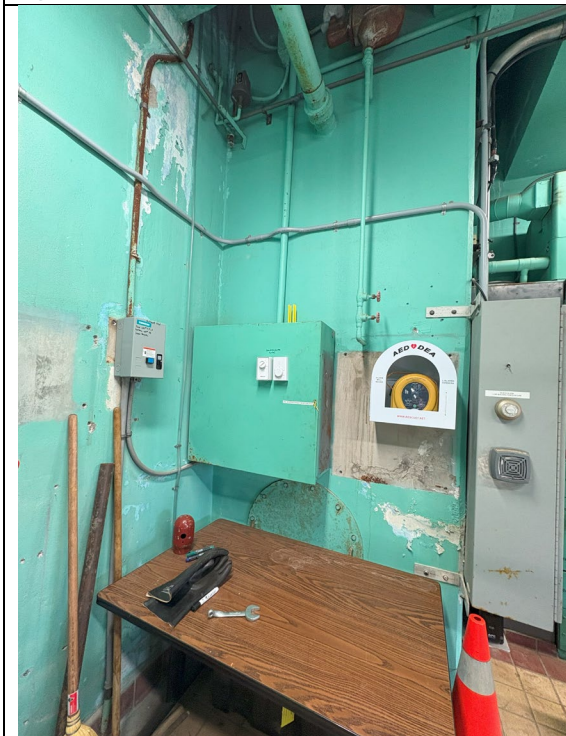
The Clonsilla Reservoir is the oldest reservoir in Peterborough, constructed in 1965. Since its construction, no changes have been made to the building or infrastructure other than routine maintenance. All equipment in the station is below grade except for the diesel motor that powers pump #4, the chlorine booster station, a shower/eye wash station, and the electrical and SCADA equipment. The exterior of the building is showing signs of aging with the precast concrete panel roof deteriorating prematurely. The interior paint is peeling and needs removal and repaint. The building is in poor to fair condition.

Figure 545: Peeling Paint

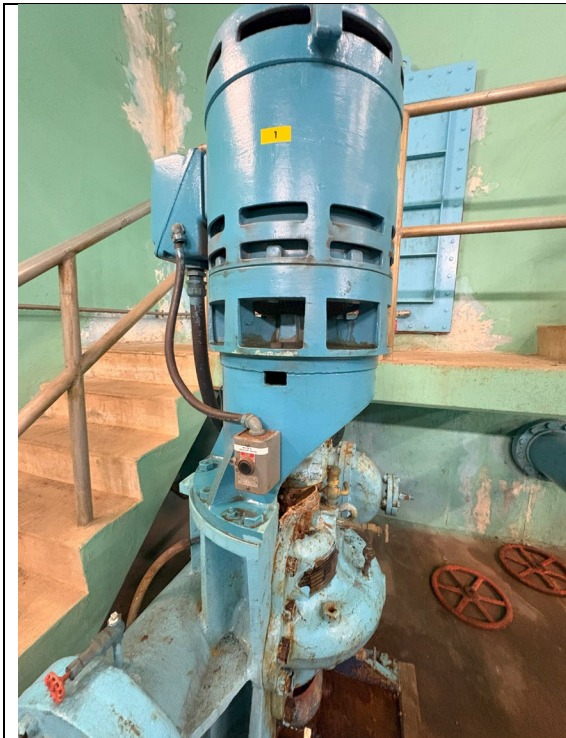
Figure 551: Pump #1

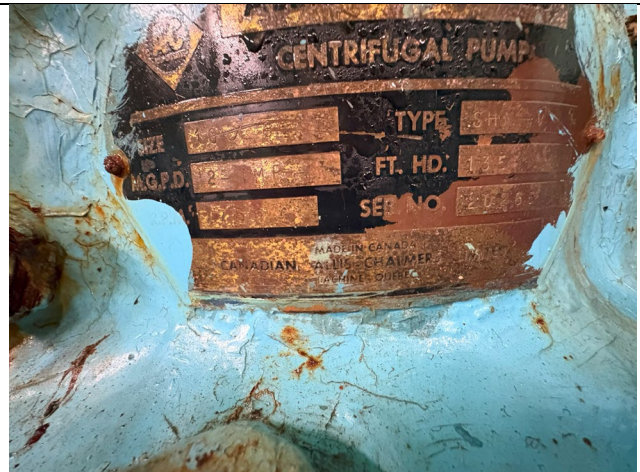
Figure 552: Label on Pump #1

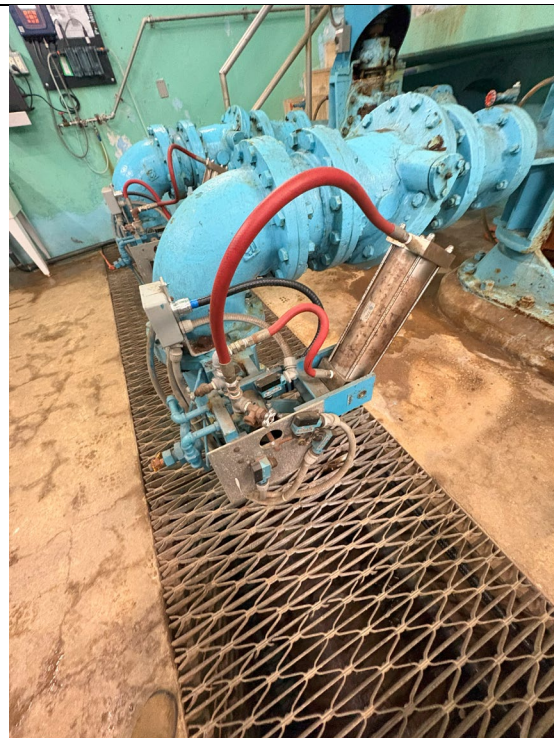
Figure 554: Hydraulic Butterfly Valve on Pump #2

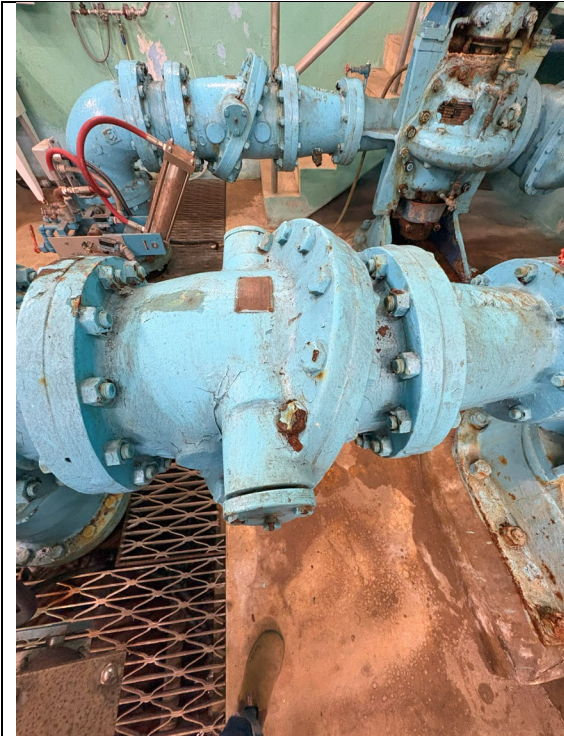
Figure 555: Check Valve on Pump #2

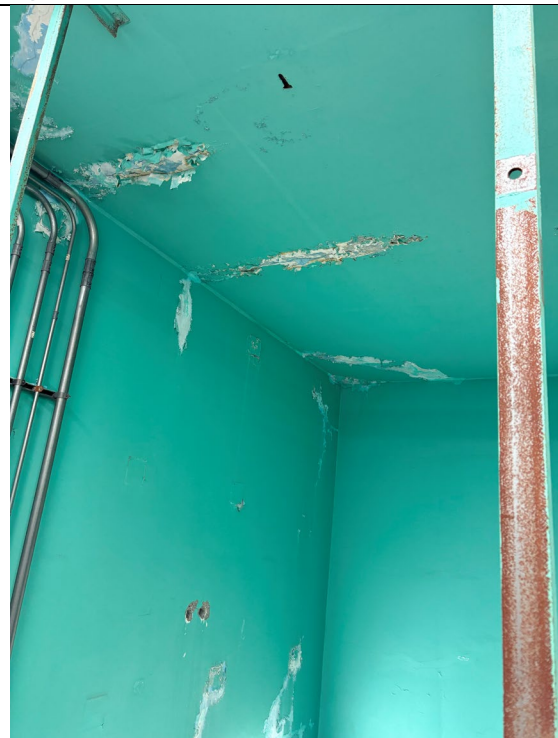
Figure 593: Peeling Paint

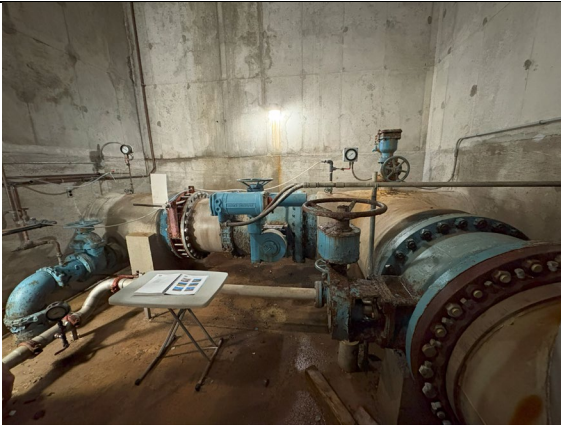
Figure 619: Process Piping

All the piping is located below the white building in the pipe room was inspected and is in fair condition. Some of the piping is experiencing corrosion due to the humid environment.

No deficiencies in power supply, lighting, drainage, or heating were expected or observed. The reservoir and bricked building are well ventilated, while the building with access to the reservoir and process piping does not have any vents. It is recommended to add ventilation

to the pumping station as it is quite humid and is causing premature corrosion to the process piping. Both buildings have exterior lights that are controlled with a switch, and the doors are secured with a smart key doorknob set. A fire extinguisher is accessible immediately inside of the door. During the inspection the reservoir was inaccessible. At the time of inspection, all services related to the building appeared to be in fair condition.

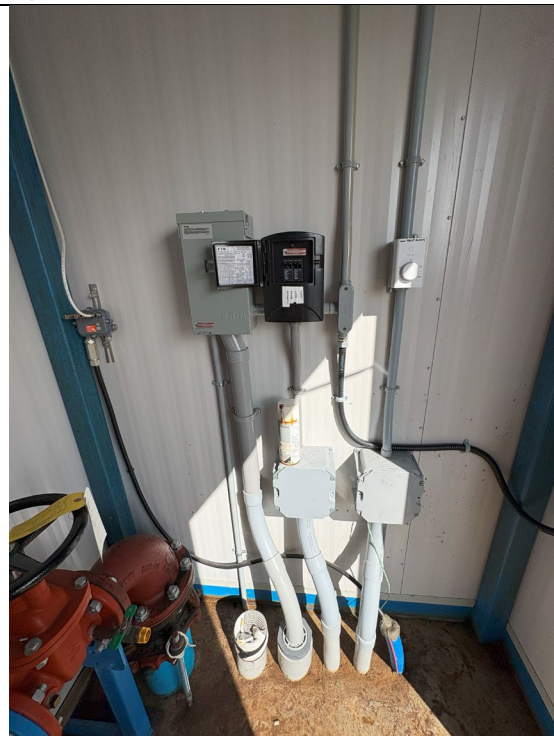
Figure 638: Electrical and Utilities Coming In
